FINAL REPORT
CPP PROJECT 9494

MCMURDO STATION SNOW MODELING

McMurdo Station, Antarctica

NOVEMBER 2016

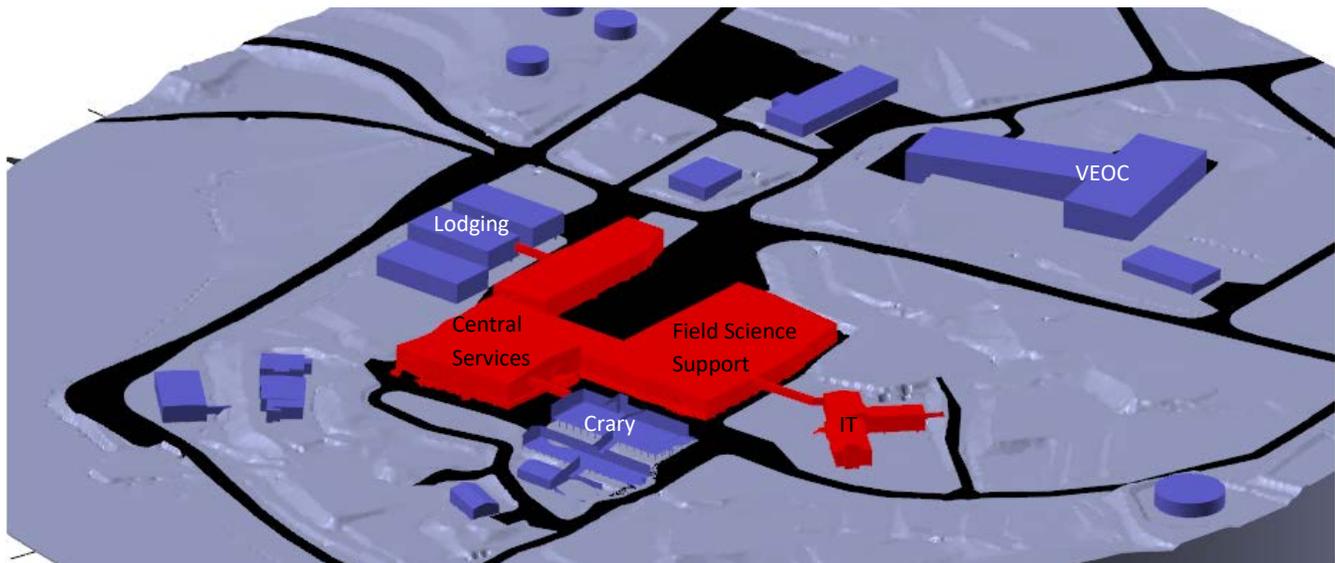
Figure 1. 3D rendering of the McMurdo building layout

CPP therefore conducted additional physical snow deposition and drift modeling of the modified campus layout of McMurdo Station. For general reference, Figure 1 shows an annotated 3D rendering of the planned McMurdo campus layout.

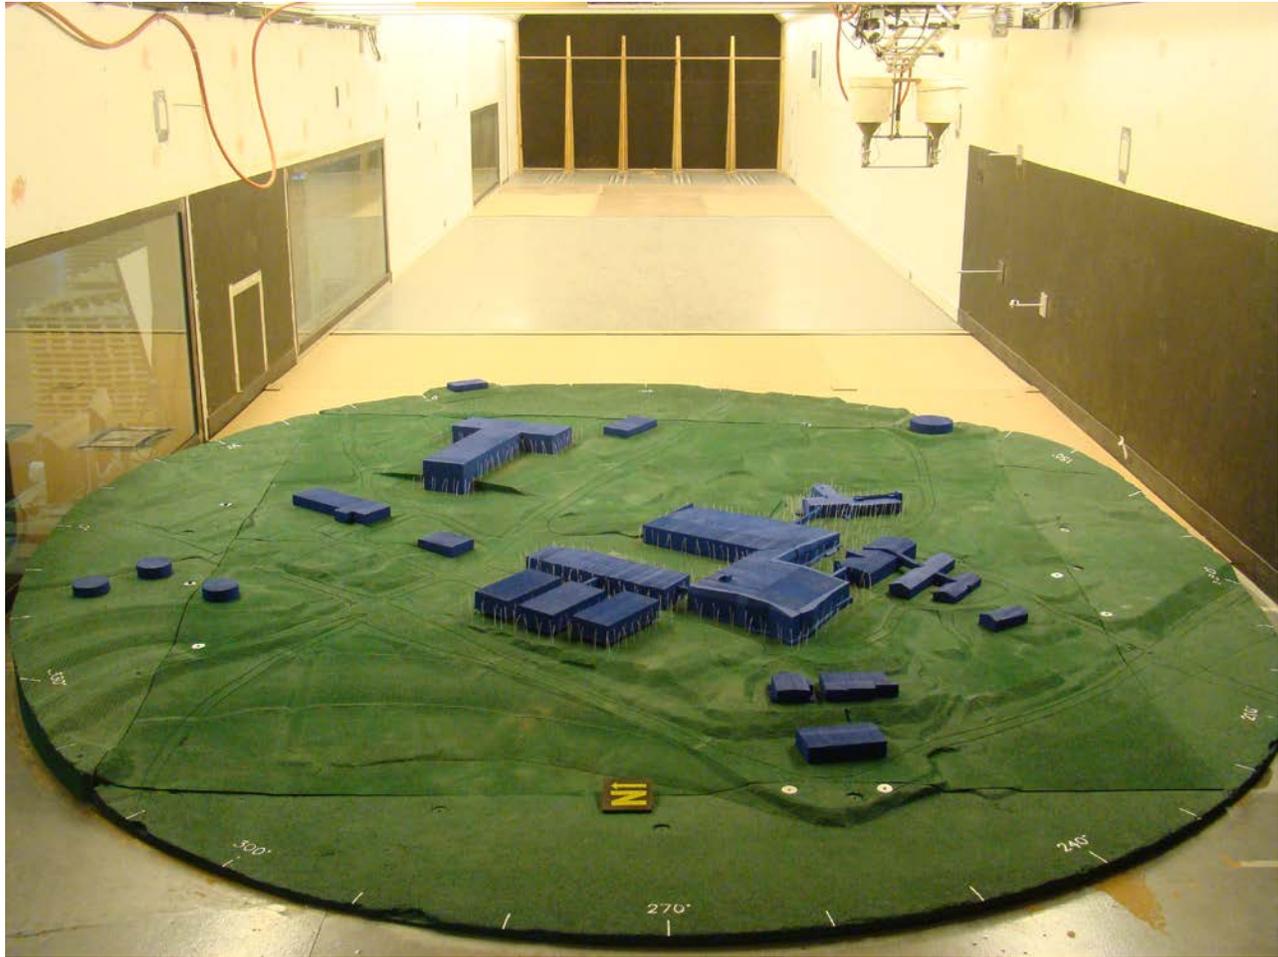
Figure 3 : Photograph of the wind-tunnel configuration. The snow deposition device is visible at the top of the photograph. The light-colored filaments on the model are measurement standards posted at each measurement location.

The terrain model under study was constructed of insulation foam board at a scale of 1:240, permitting a reasonable test model size with an adequate portion of the adjoining environment to be included in a proximity model, and was well within wind-tunnel blockage limitations. The extent of modeled area on the turntable is shown in Figure 4. Buildings were constructed of foam blocks to the same scale. The IT Building, the Central Services Building edges and the delicate stilts under some of the other buildings were constructed of wood or by stereolithography. Photographs of the model are shown in Figure 3 and in Section 3.

A snow deposition device (Figure 3) was positioned above and upstream of the model so that the falling snow would be deposited on the turntable area with a uniform distribution over the test model. A calibration of the system was performed prior to testing with the model replaced by a flat, open-country environment to ensure that a uniform snowfall occurred over the turntable. Wind speed in the wind tunnel was set at 2.5 m/s for the snow deposition. In the calibration, a measured volume of snow was deposited on the open area until its depth was 0.2 inches. Snow measurement sticks were fabricated using thin lengths of plastic, marked with a color scale and were placed at regular intervals in the test section to simplify the snow depth measurement procedure. The baseline depth represents 48 inches full scale, a relatively large snow depth. This is significantly larger than the record for McMurdo of about 14 inches of snowfall in a 24-hour period. The purpose of the wind tunnel study is, however, to establish deposition and drift ratios that can be applied to any large storm.

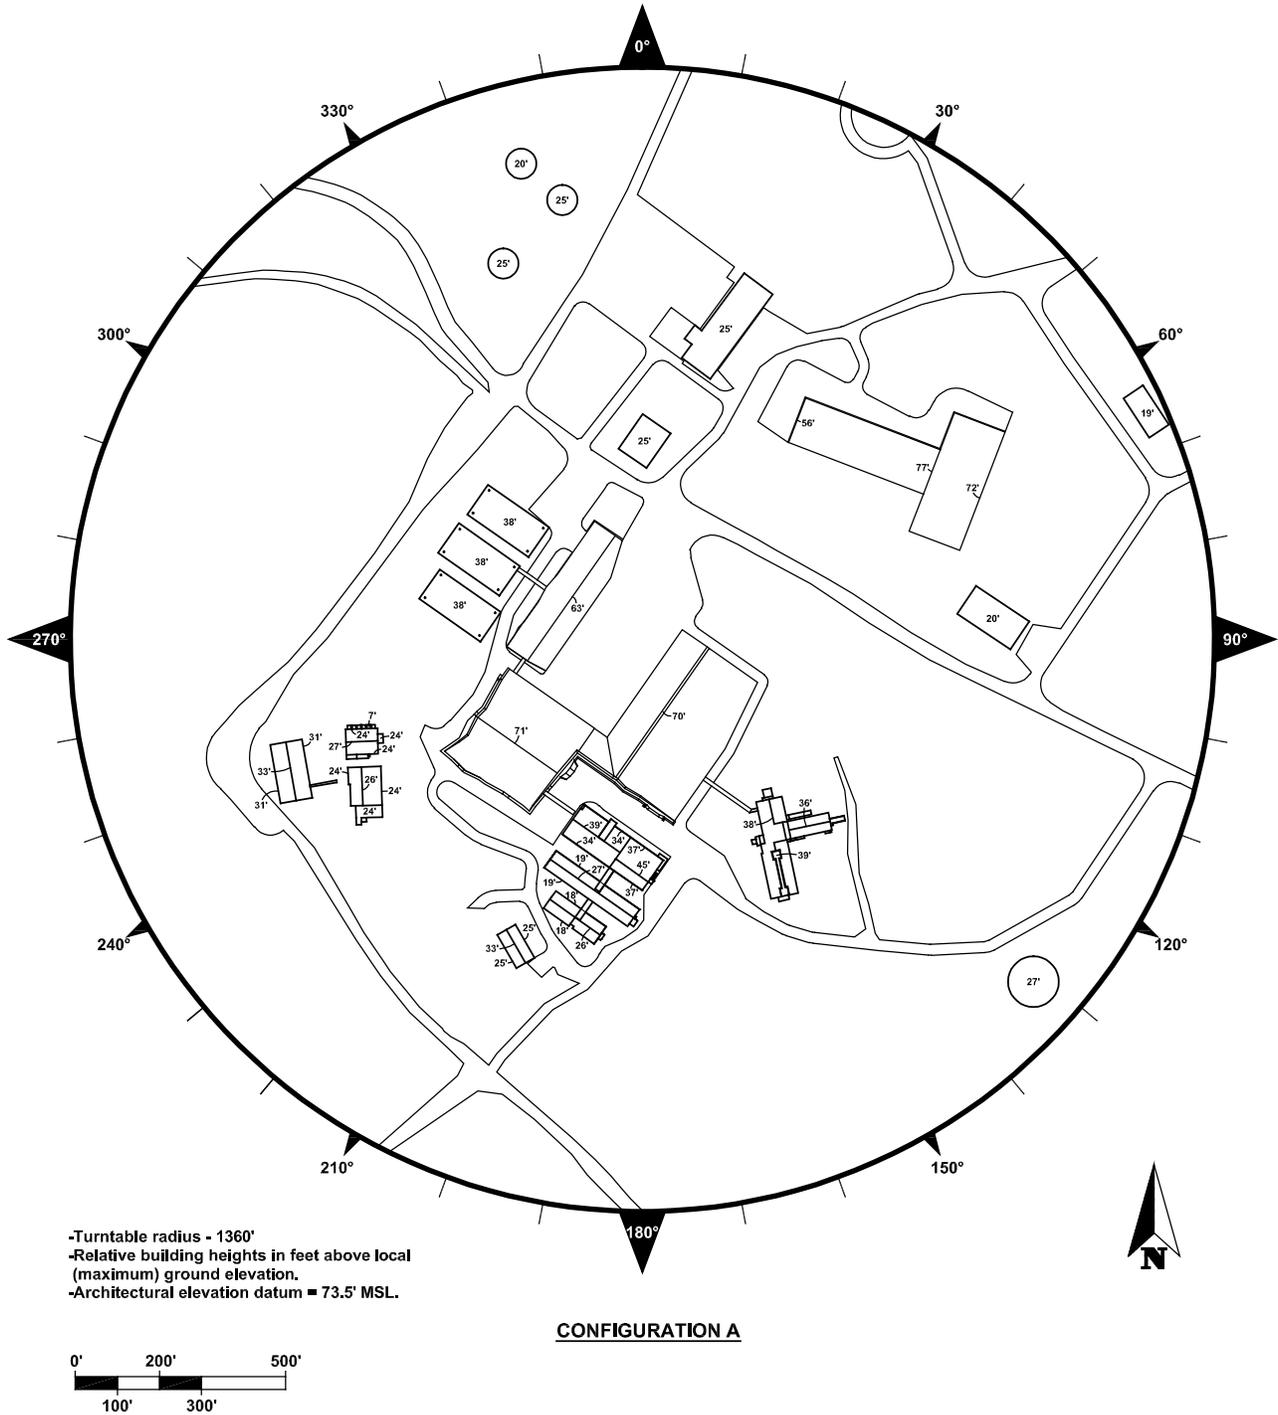
Figure 4a: Site plan of the McMurdo Station with building heights: Model Configuration A

A site plan of the model configuration A with building heights is shown in Figure 4a. Photographs of the model setup in the wind tunnel are shown below in Figure 6.

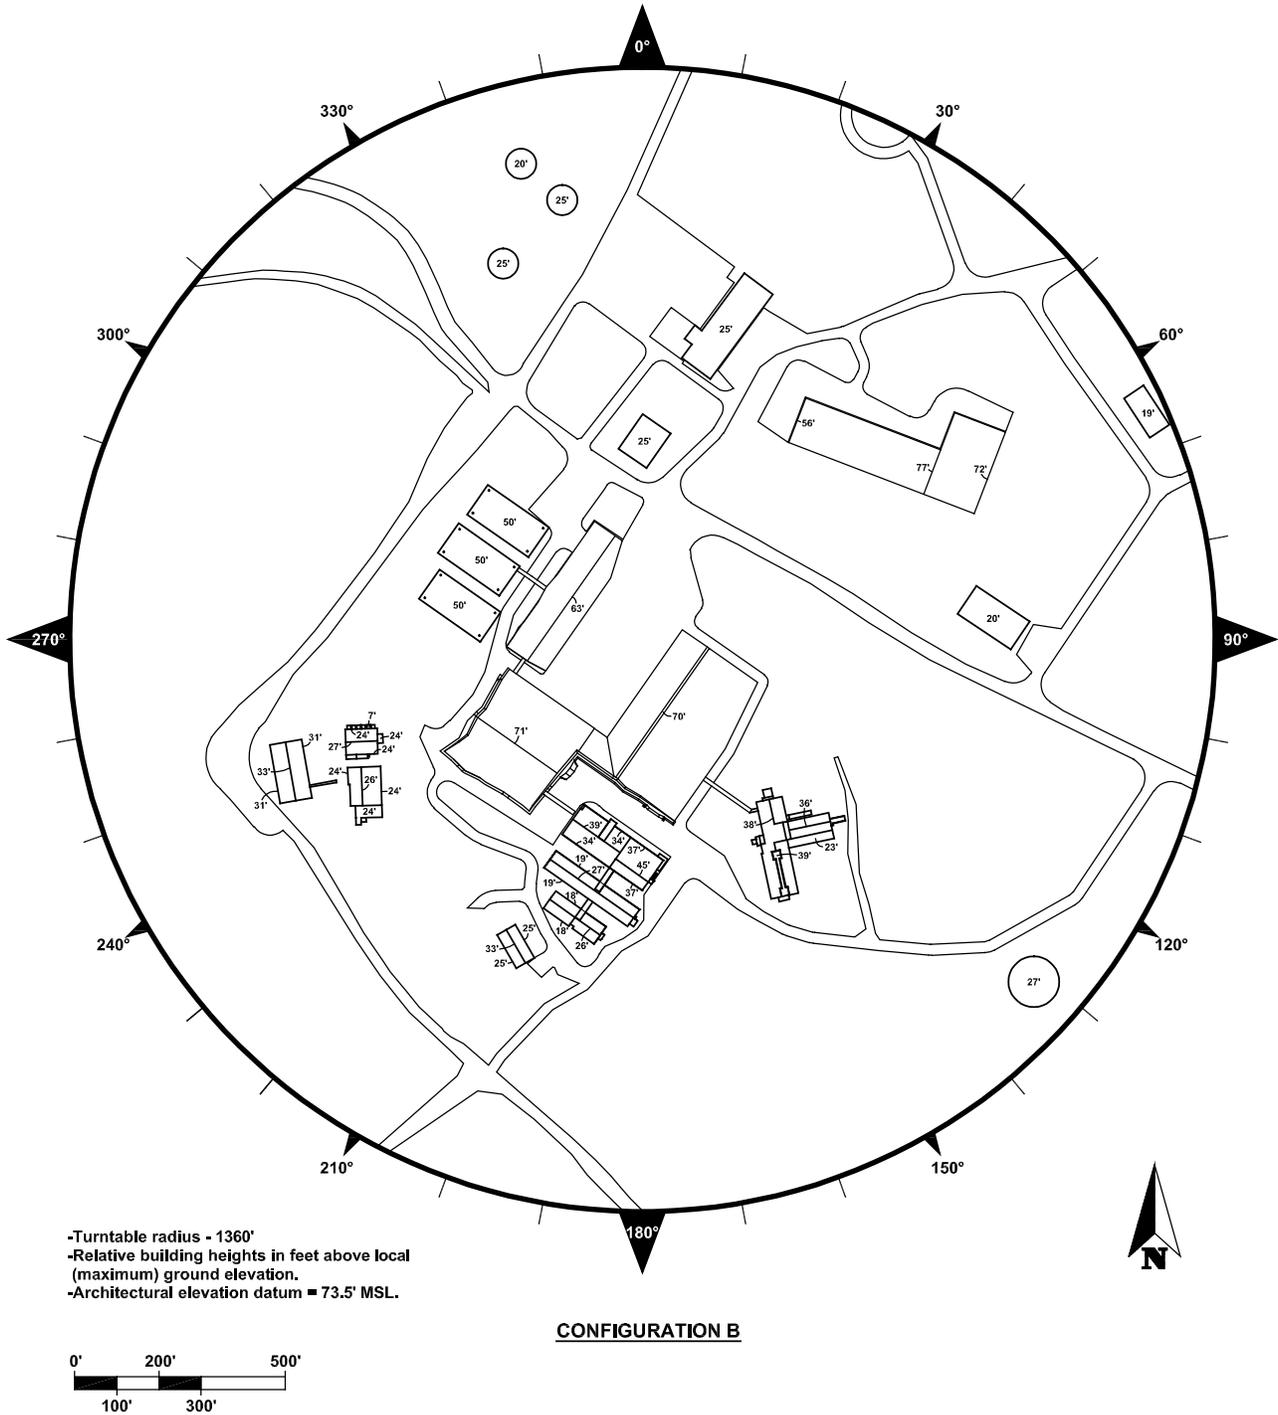
Figure 4b: Site plan of the McMurdo Station with building heights: Model Configuration B

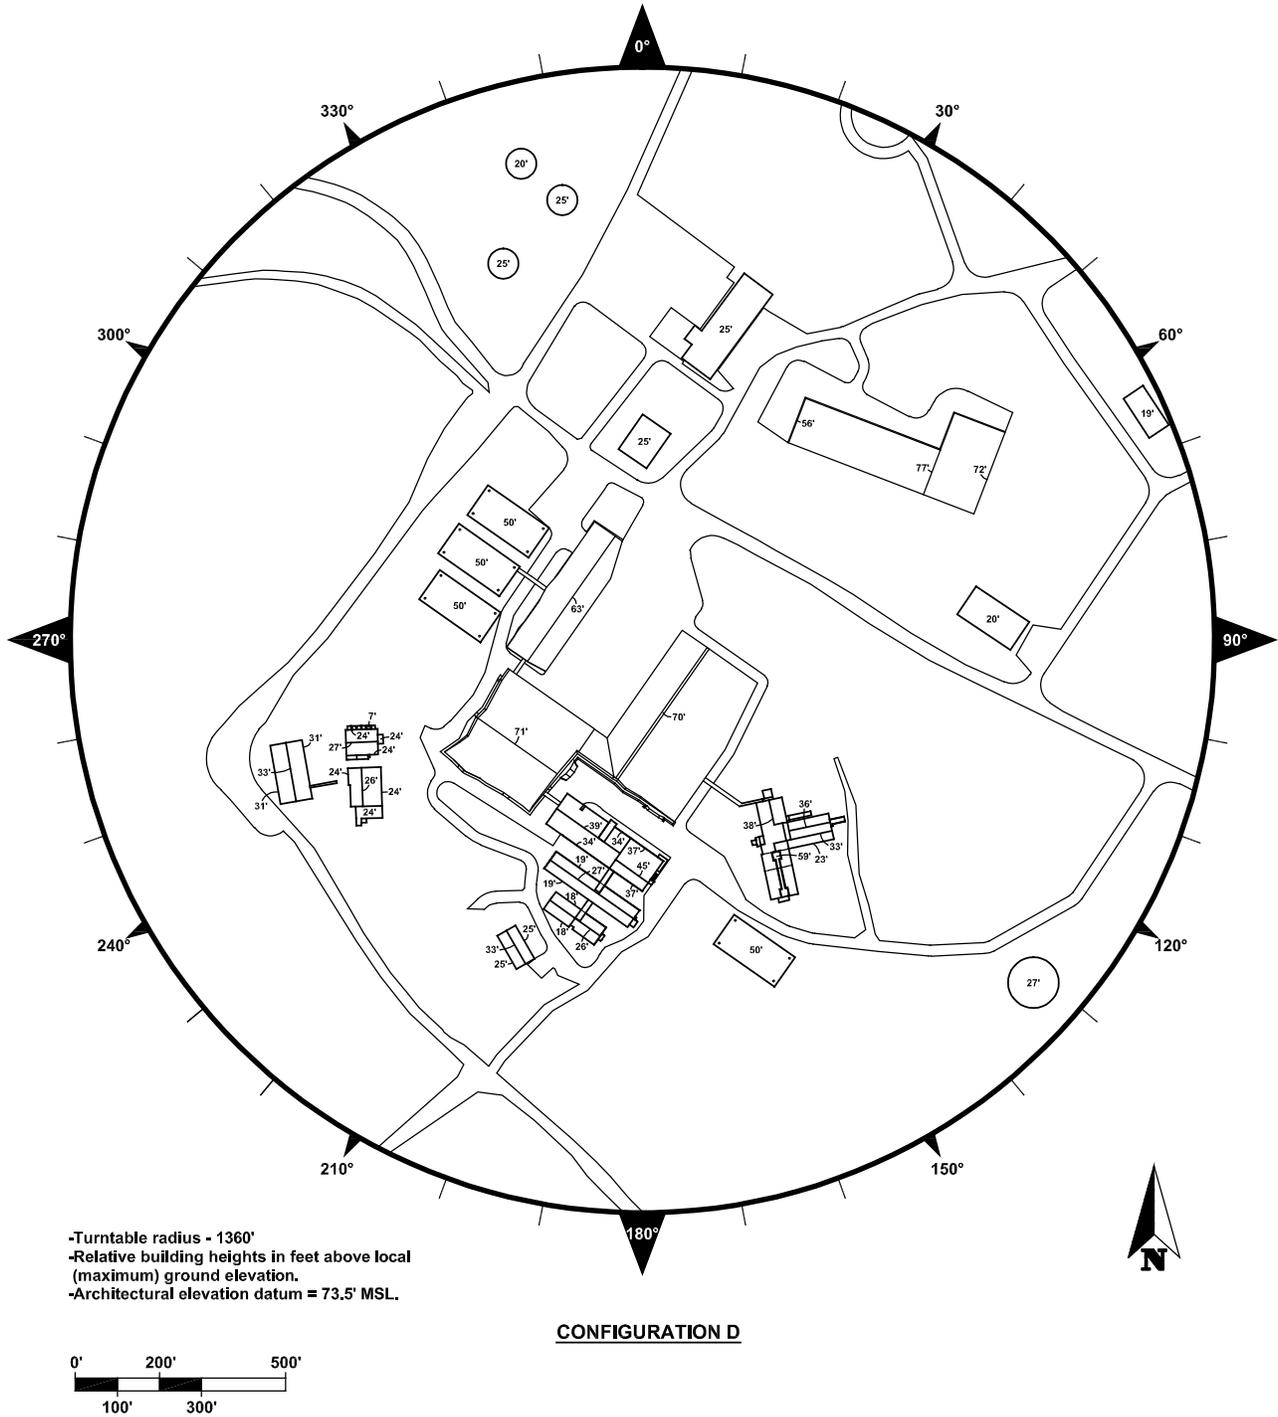
Figure 4d: Site plan of the McMurdo Station with building heights: Model Configuration D

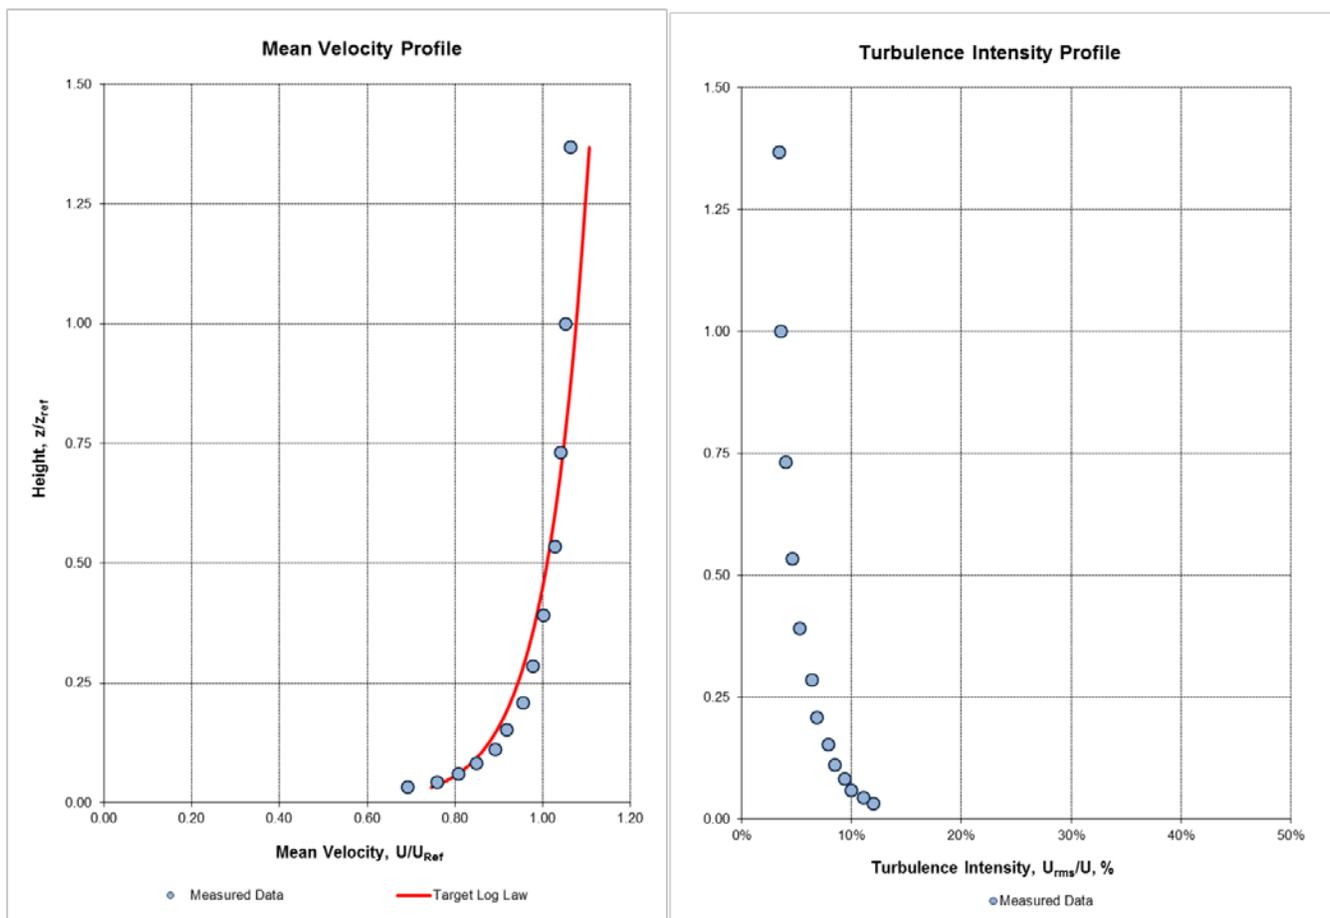
Figure 5 : Wind tunnel measured velocity and turbulence profiles approaching the model.

Mean velocity and turbulence intensity profiles for the boundary layer flow approaching the modeled area are shown in Figure 5. The mean velocity profile approaching the modeled area can be described in form of the “log-law” and is given by:

in which U is the mean velocity at height z , U_* is the friction velocity, z_o is the surface roughness length ($z_o=0.001\text{m}$ is estimated in full scale for the open snow/ice exposure of McMurdo Station) and k is von Kàrman’s constant (which is generally taken to be 0.4). The measured turbulence intensities are appropriate for the approach mean velocity profile selected.

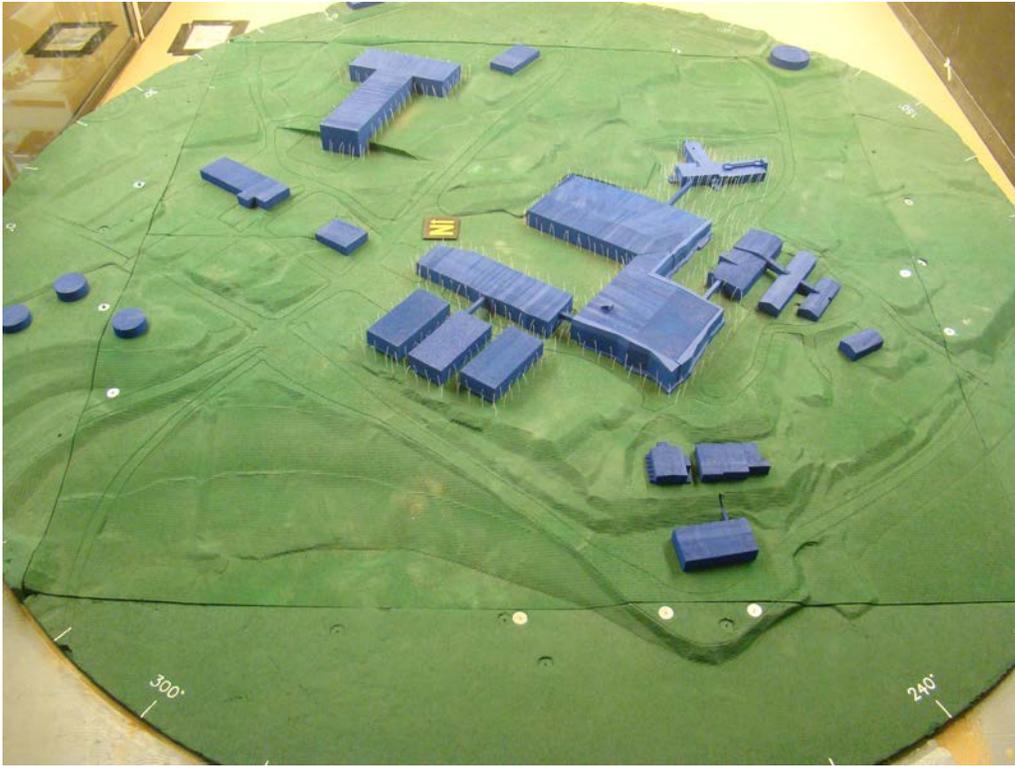
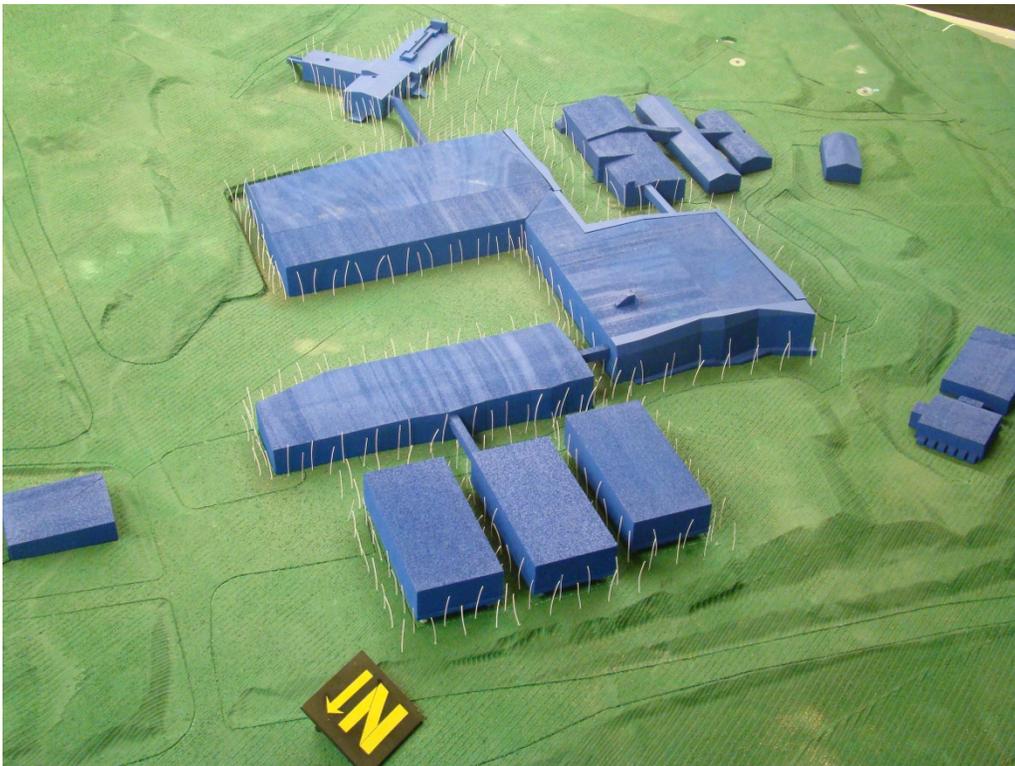
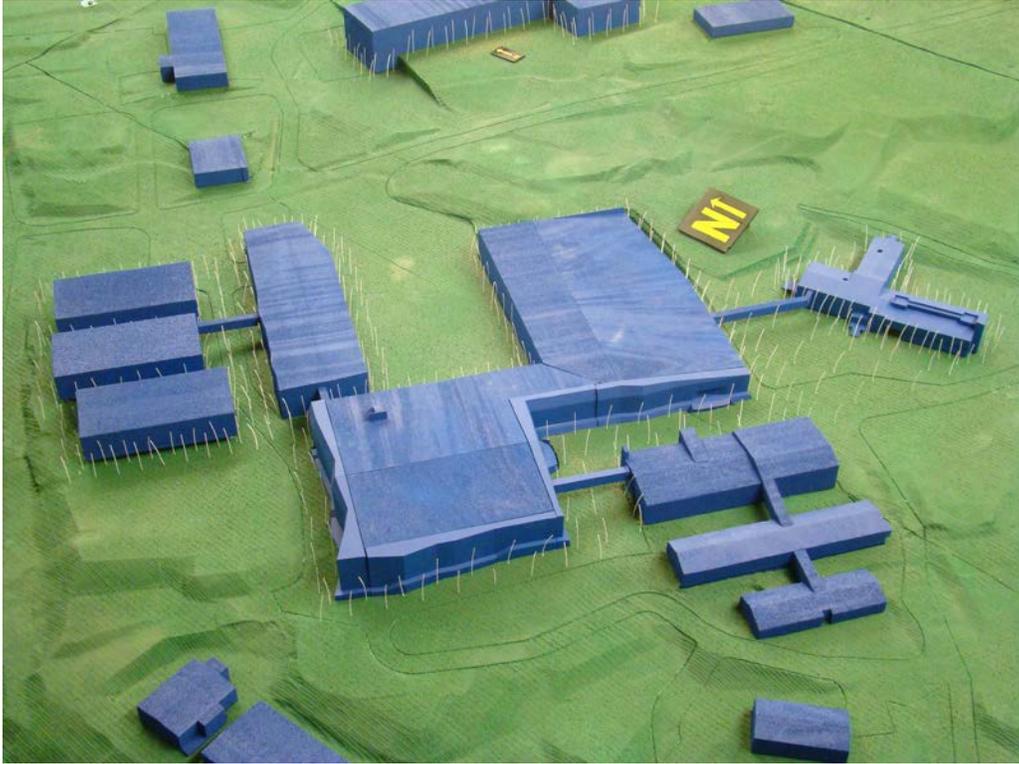
Figure 6a: Photographs of the model setup in the wind tunnel for Model Configuration A: View from the west.

Figure 6b: Photographs of the model setup in the wind tunnel for Model Configuration A: View from the north.

Figure 6c: Photographs of the model setup in the wind tunnel for Model Configuration A: View from the south.

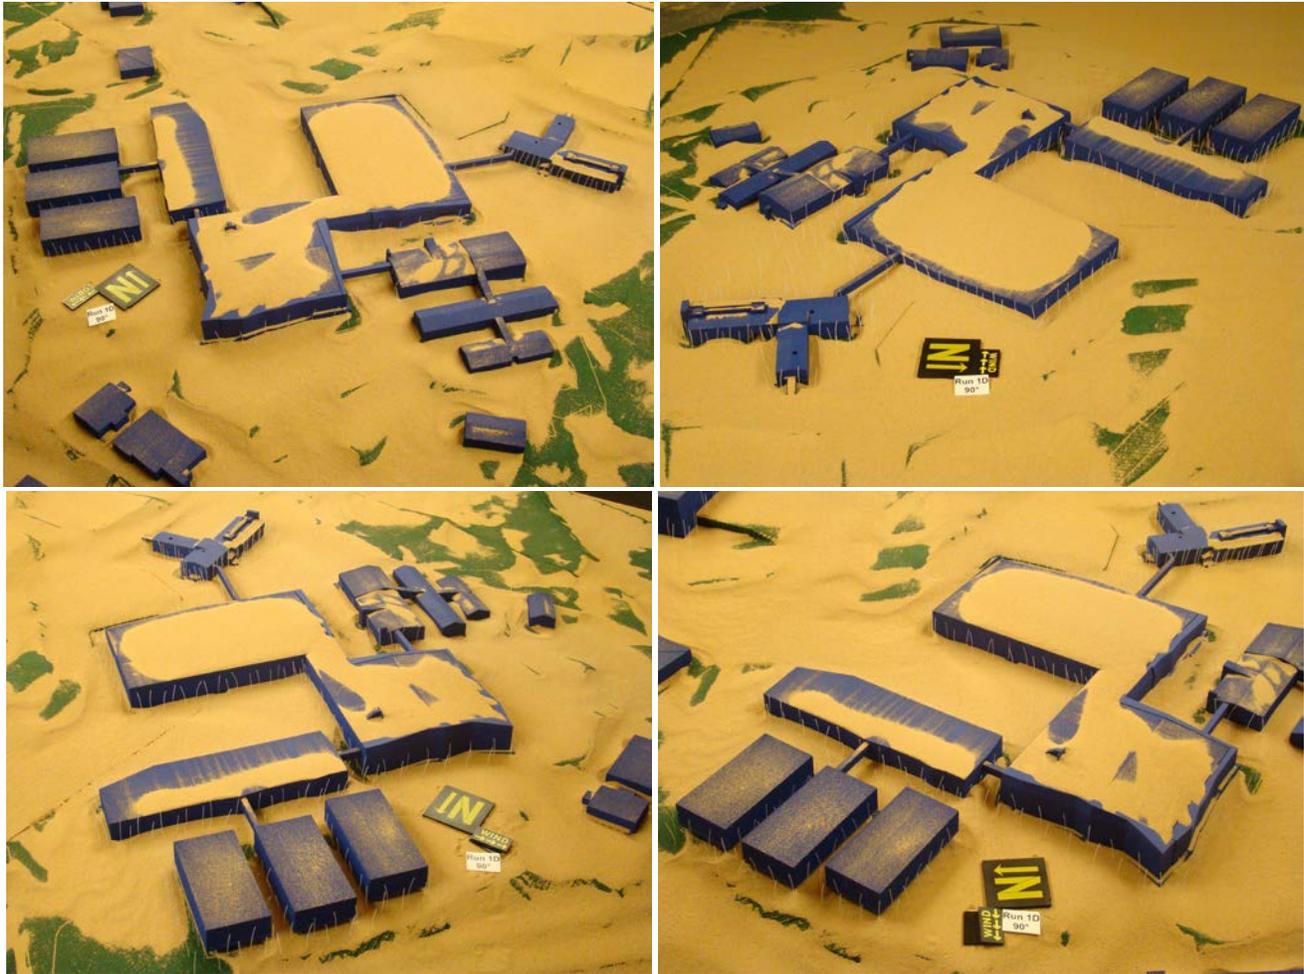
Figure 7a: Photographs of the snow accumulation and scouring: Case 1: Model Configuration A with a wind direction of 90°.

Snow material was deposited and drifted on the model as described in Section 2.2. Photographs of the resulting snow accumulation and scouring patterns are shown in Figure 7a and Figure 7b for the east and south-southeast wind directions. Site plans with color-coded measured snow depths for both wind directions are shown in Figure 8. Drawings with snow depths, color-coded by depth, for all cases are shown in Appendix A. The color scale is linear and ranges from blue (less than half of the open field [0.2-inch] calibration depth) to red (more than 2.5 times the open field [0.2-inch] calibration depth).

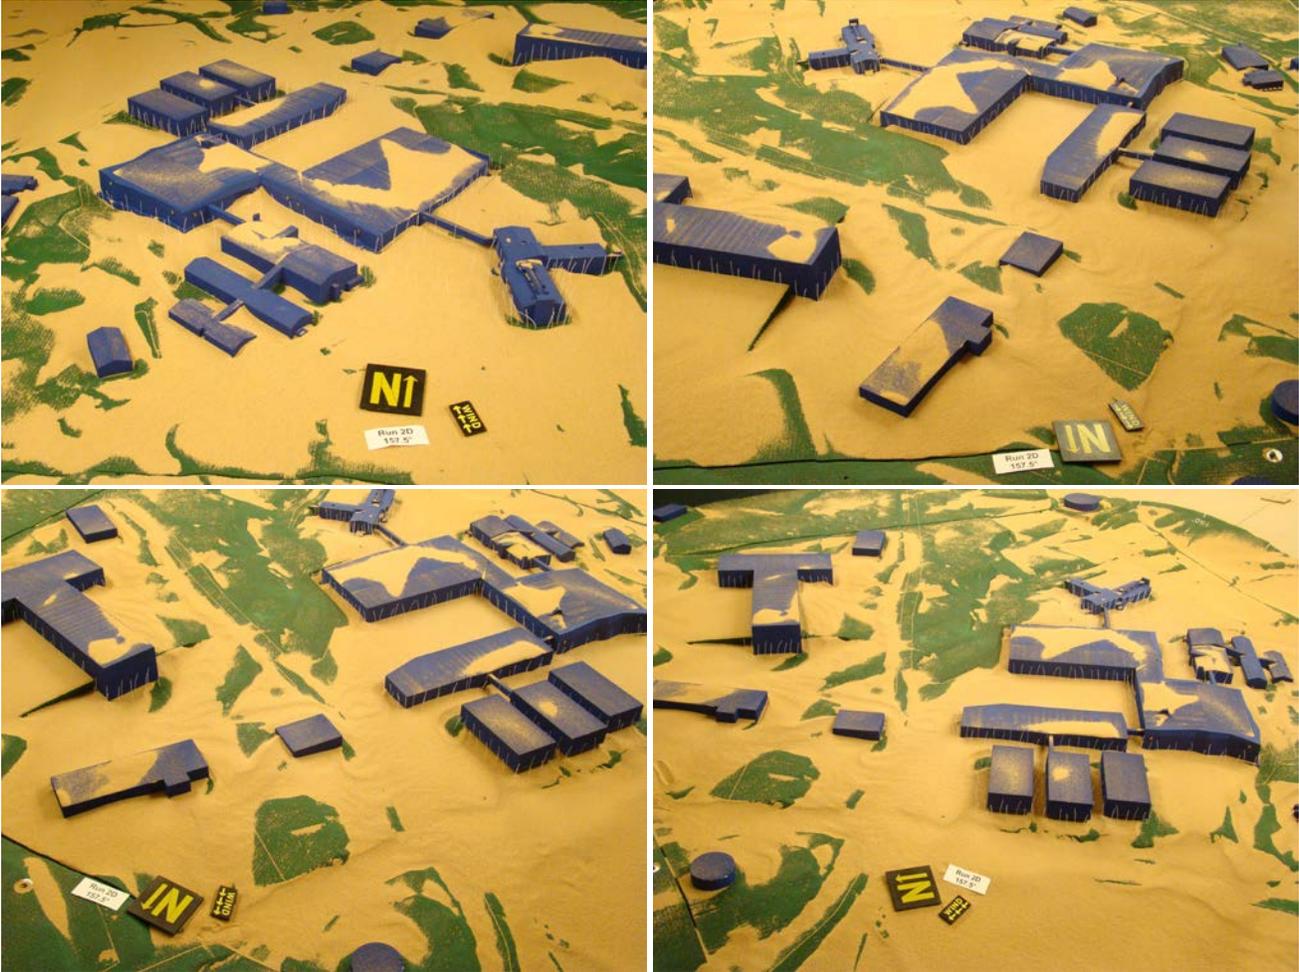
Figure 7b: Photographs of the snow accumulation and scouring: Case 2: Model Configuration A with a wind direction of 157.5°.

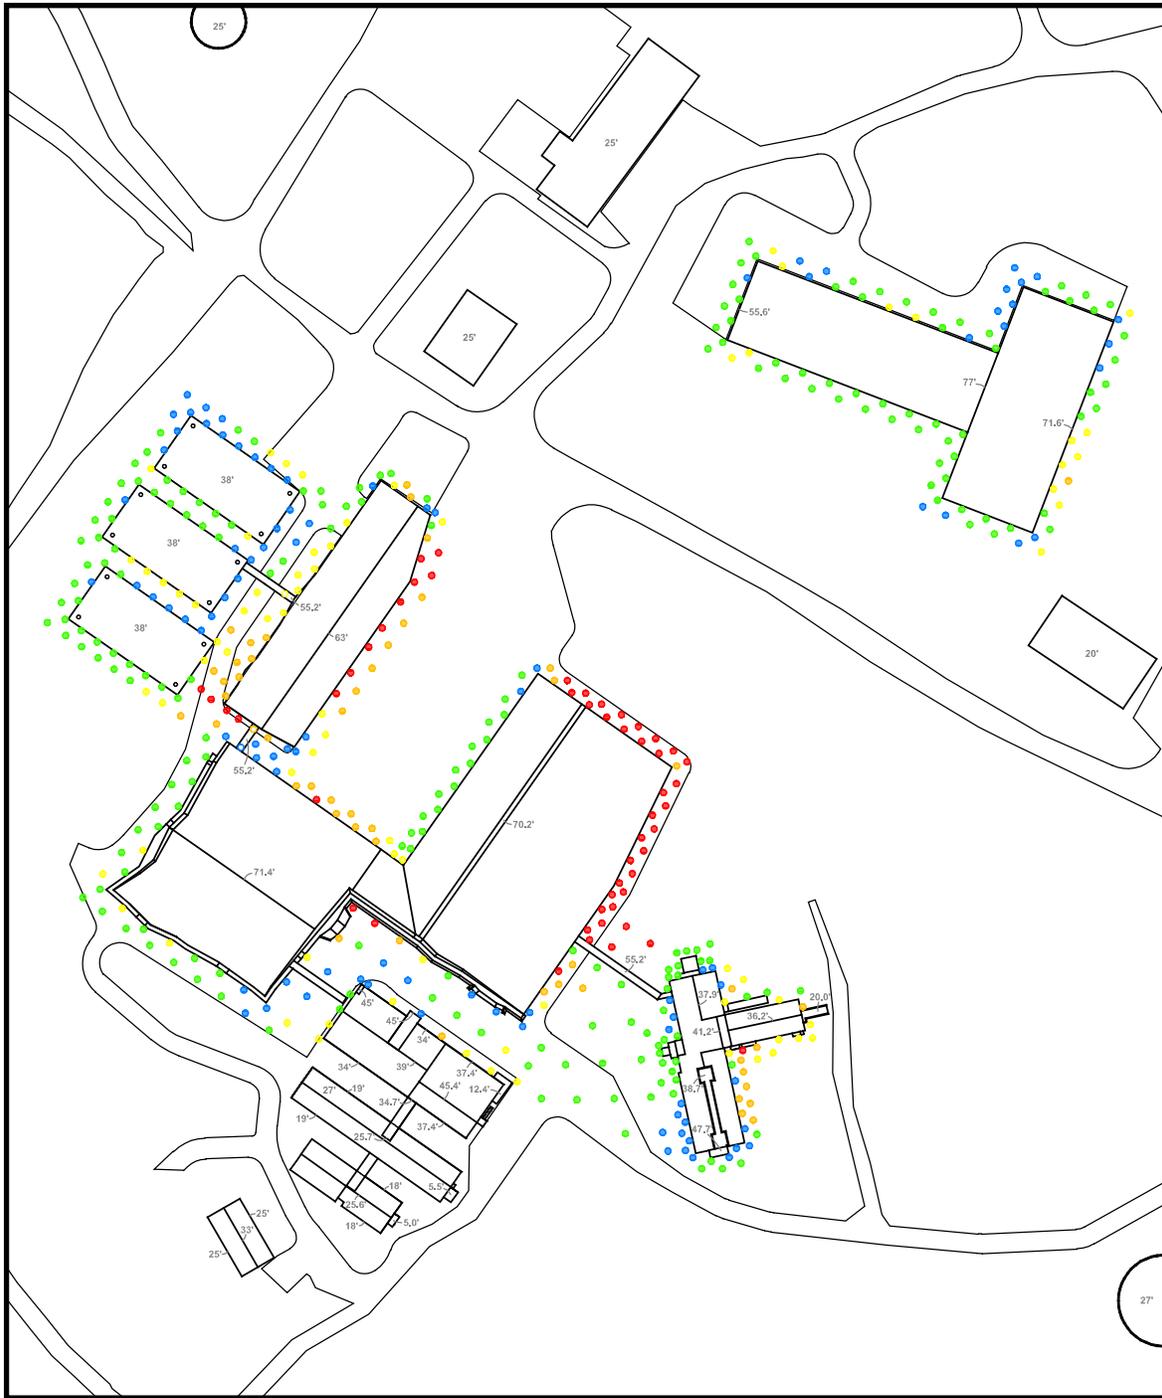
RUN 1D-90°

SNOW DEPTH
 • - Lightest
 •
 •
 •
 • - Deepest

Figure 8a: Measured snow depths: Case 1: Model Configuration A with a wind direction of 90°.

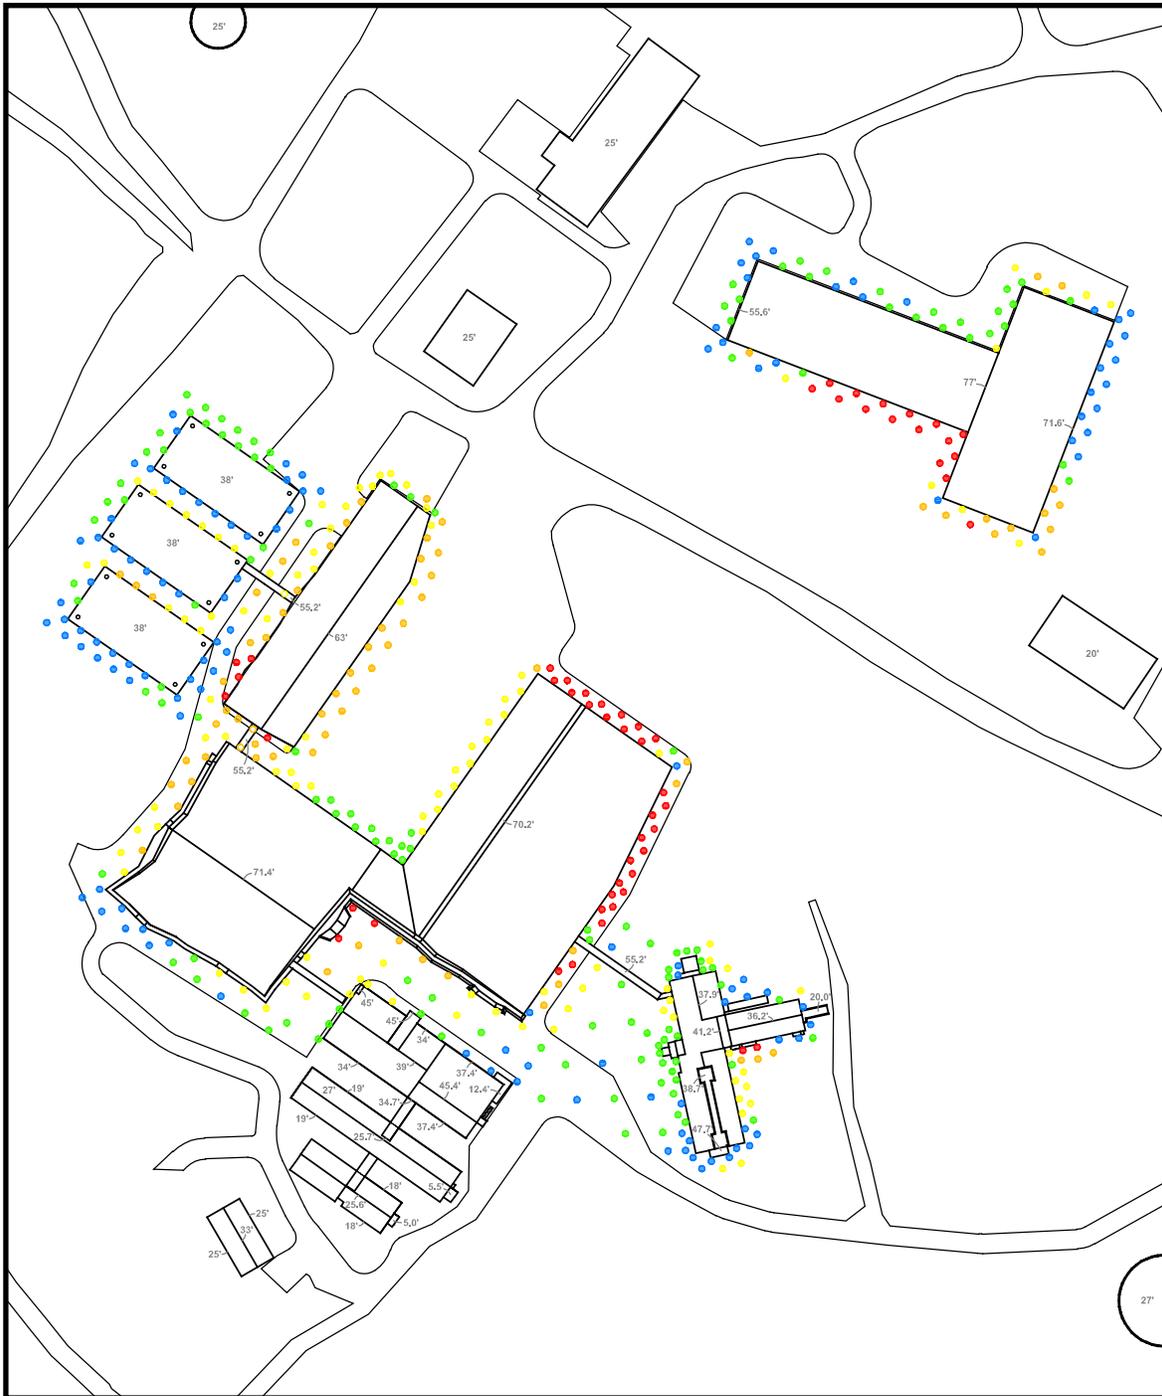
RUN 2D-157.5°

SNOW DEPTH
 • - Lightest
 • - Intermediate
 • - Deepest

Figure 8b: Measured snow depths: Case 2: Model Configuration A with a wind direction of 157.5°.

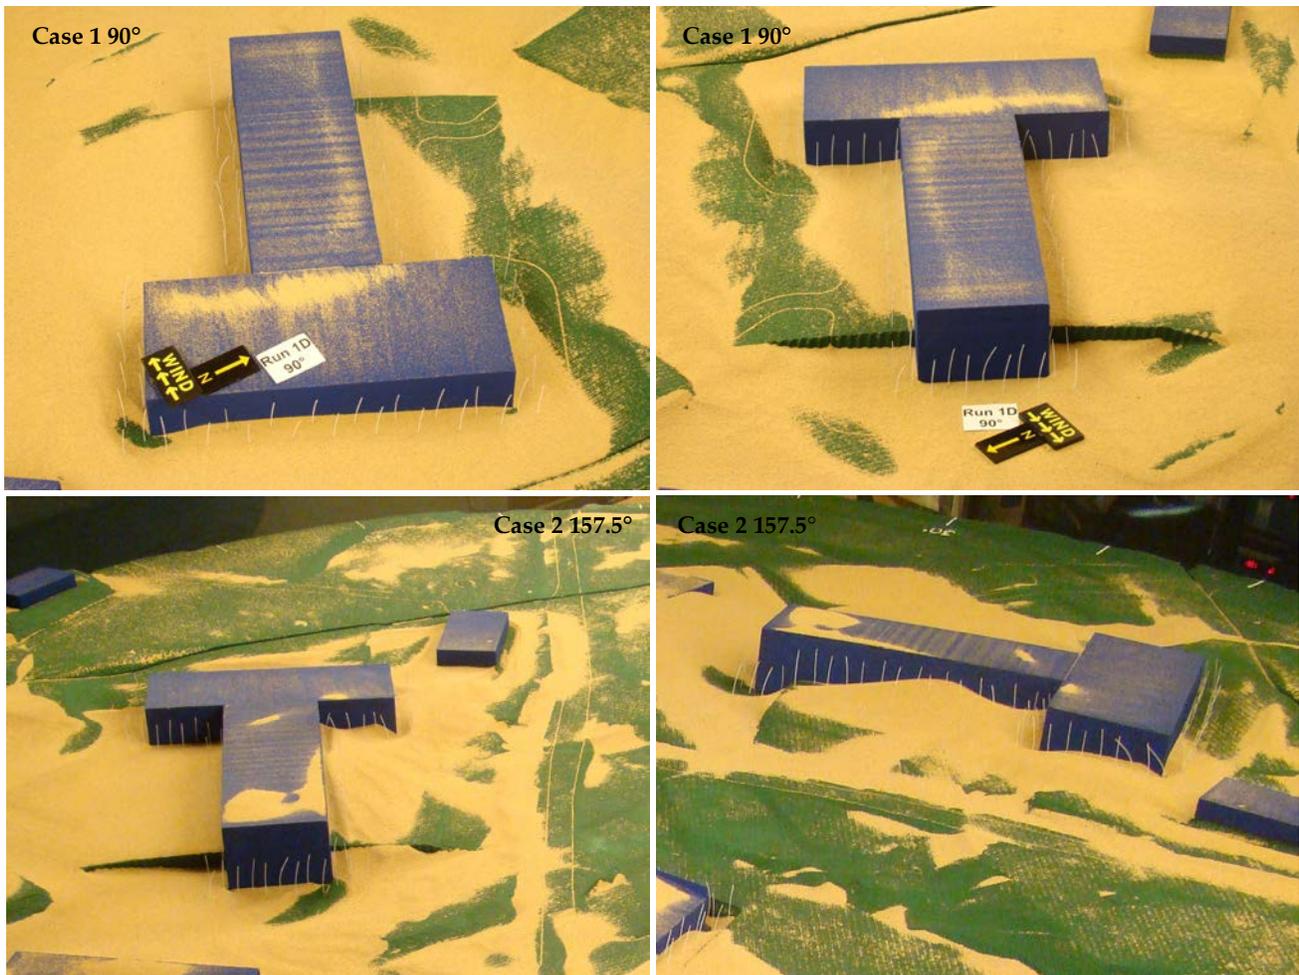
Figure 9 : Photographs of the snow accumulation and scouring around the VEOC (Model Configuration A).

The snow accumulation around the VEOC is shown in the photographs below. Only a slight increase above ambient snow levels can be seen along the east wall of the VEOC building for easterly wind directions. For south-southeast winds, significant snow accumulation is observed along the southern building walls. Snow scour is observed in places where the wind accelerates, such as around corners. For the south-southeast wind direction, snow along the east side of the building is almost completely scoured away.

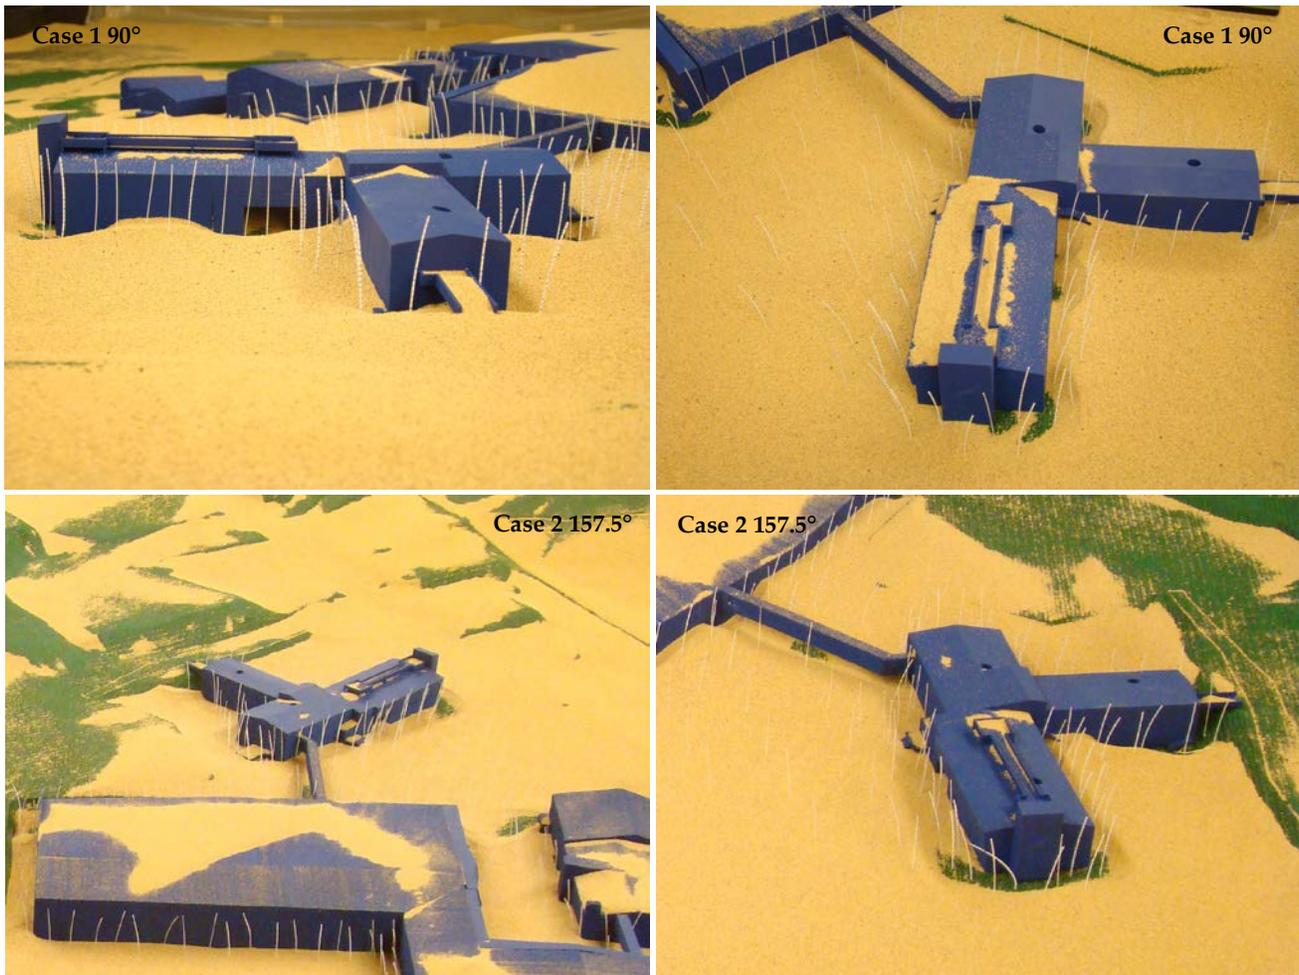
Figure 10 : Photographs of the snow accumulation and scouring around the IT Building (Model Configuration A).

Photographs of the snow accumulation around the IT Building are shown in Figure 10 below. Significant snow accumulation can be seen in the pocket created by the existing east wing and the new south wing of the building. The breezeway stayed mostly clear of snow for both wind directions.

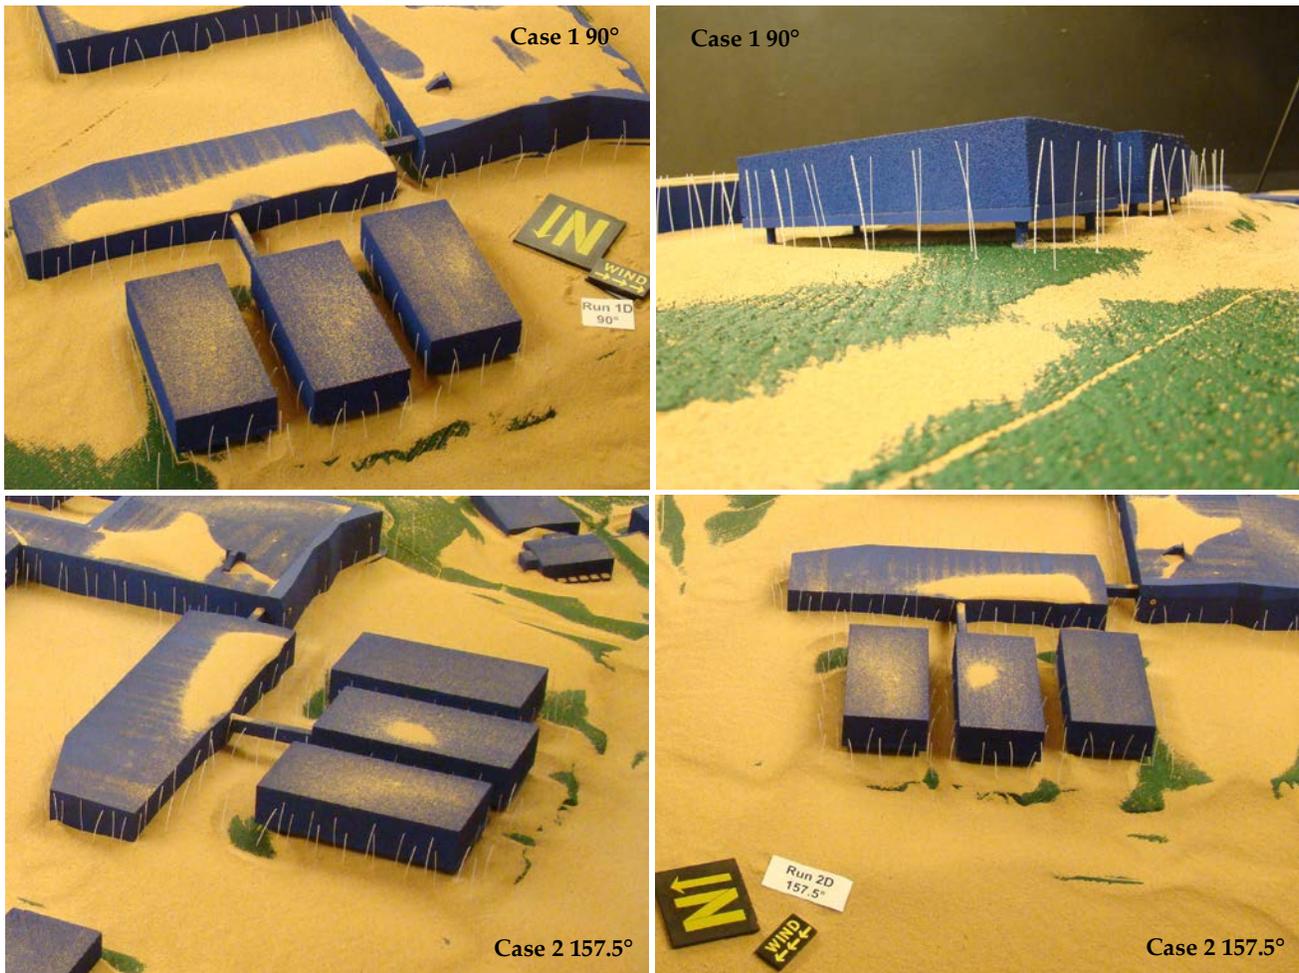
Figure 11 : Photographs of the snow accumulation and scouring around the Lodging Buildings (Model Configuration A).

Overall, snow deposition around the Lodging Buildings is minor, as shown in the photographs below. The wind accelerates around the building corners, scouring the snow in these areas. Some accumulation can be observed between the buildings; however, the area underneath the buildings stays fairly clear.
