FINAL REPORT
CPP PROJECT 9494

MCMURDO STATION SNOW MODELING

McMurdo Station, Antarctica

NOVEMBER 2016

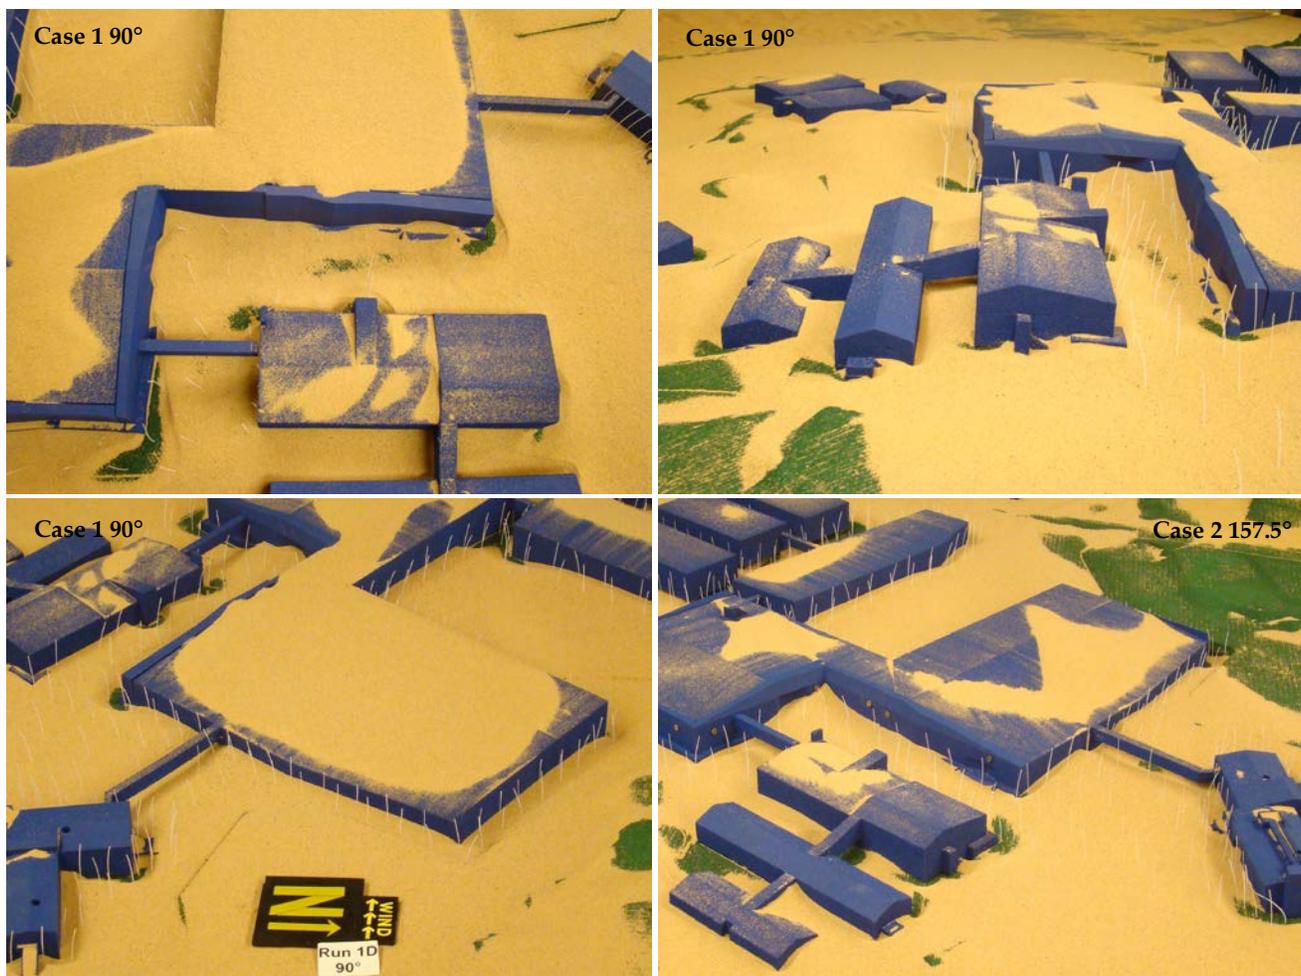
Figure 12 : Photographs of the snow accumulation and scouring around the Central Services and Field Science Support Buildings (Model Configuration A).

For both wind directions, significant snow accumulation was observed along the north walls of the main entrance area (similar to the accumulation observed during the previous wind tunnel assessment), as well as along the east wall of the Field Science Support Building (see photos below).

Significant snow scouring was observed between Crary and Field Science Support and along the gap between Central Services and Crary. For the 157.5° wind direction, wind flows both through the gap between Central Services and Crary and along the main entry way, creating a snow trap in the northwest corner of the main entrance area.

The proposed grading plan creates a pocket along the north and east sides of the Field Science Support Building, which –fills almost completely with the snow material.

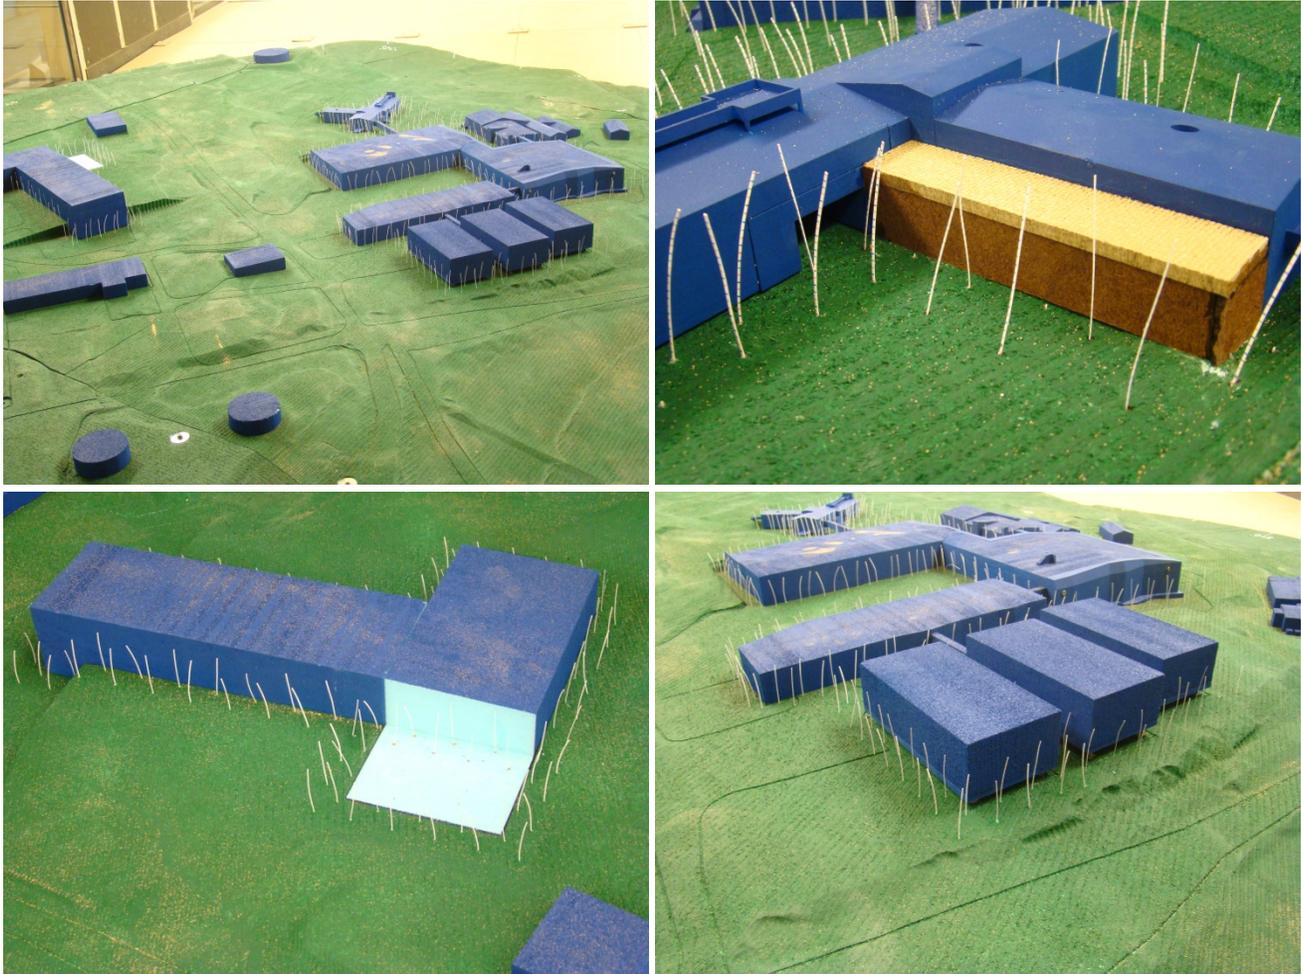
Figure 13: Photographs of the model setup in the wind tunnel for Model Configuration B.

Several building changes were evaluated for the two different wind directions. In Cases 3 and 4, taller dorm buildings were installed and the cold storage facility was added to the IT Building. The south wing of the VEOC Building was removed as well. Photographs of the individual buildings are shown below (Figure 13).

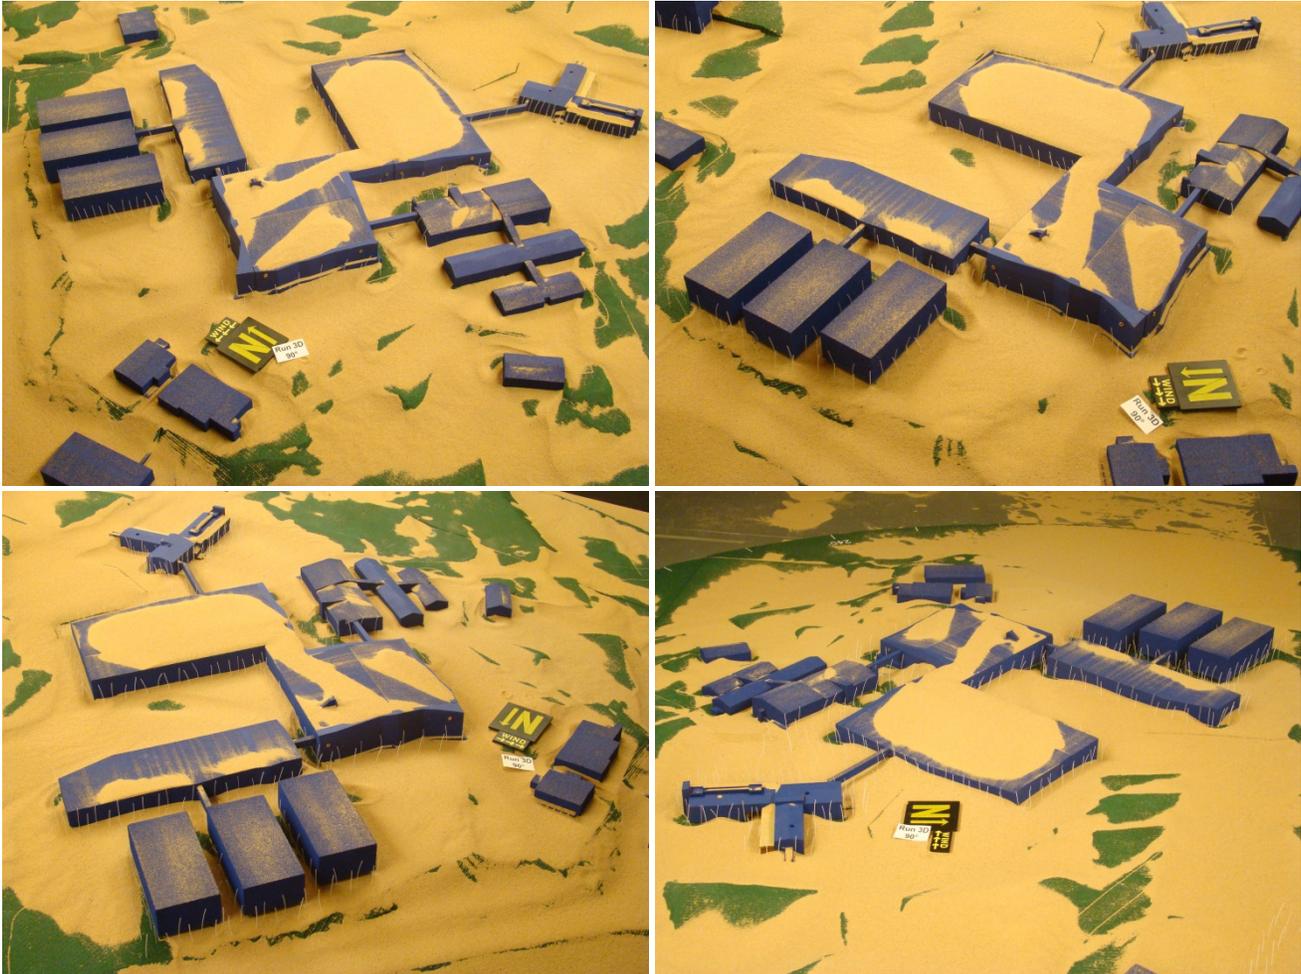
Figure 14a: Photographs of the snow accumulation and scouring: Case 3: Model Configuration B with a wind direction of 90°.

Photographs of the resulting snow accumulation and scouring patterns for Cases 3 and 4 are shown in Figure 14. Drawings with the color-coded snow depths for all test cases are shown in Appendix A.

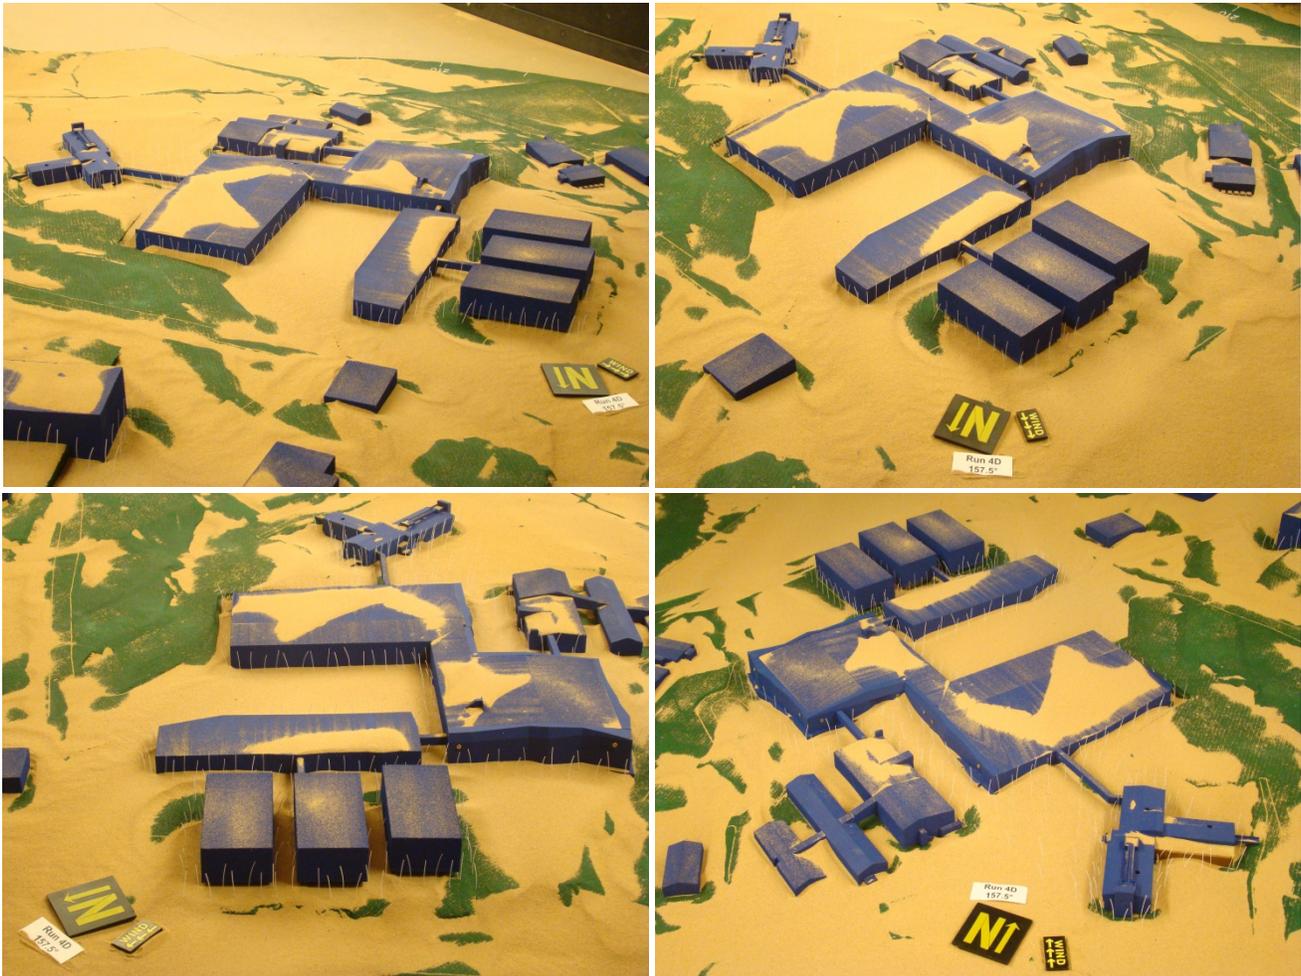
Figure 14b: Photographs of the snow accumulation and scouring: Case 4: Model Configuration B with a wind direction of 157.5°.

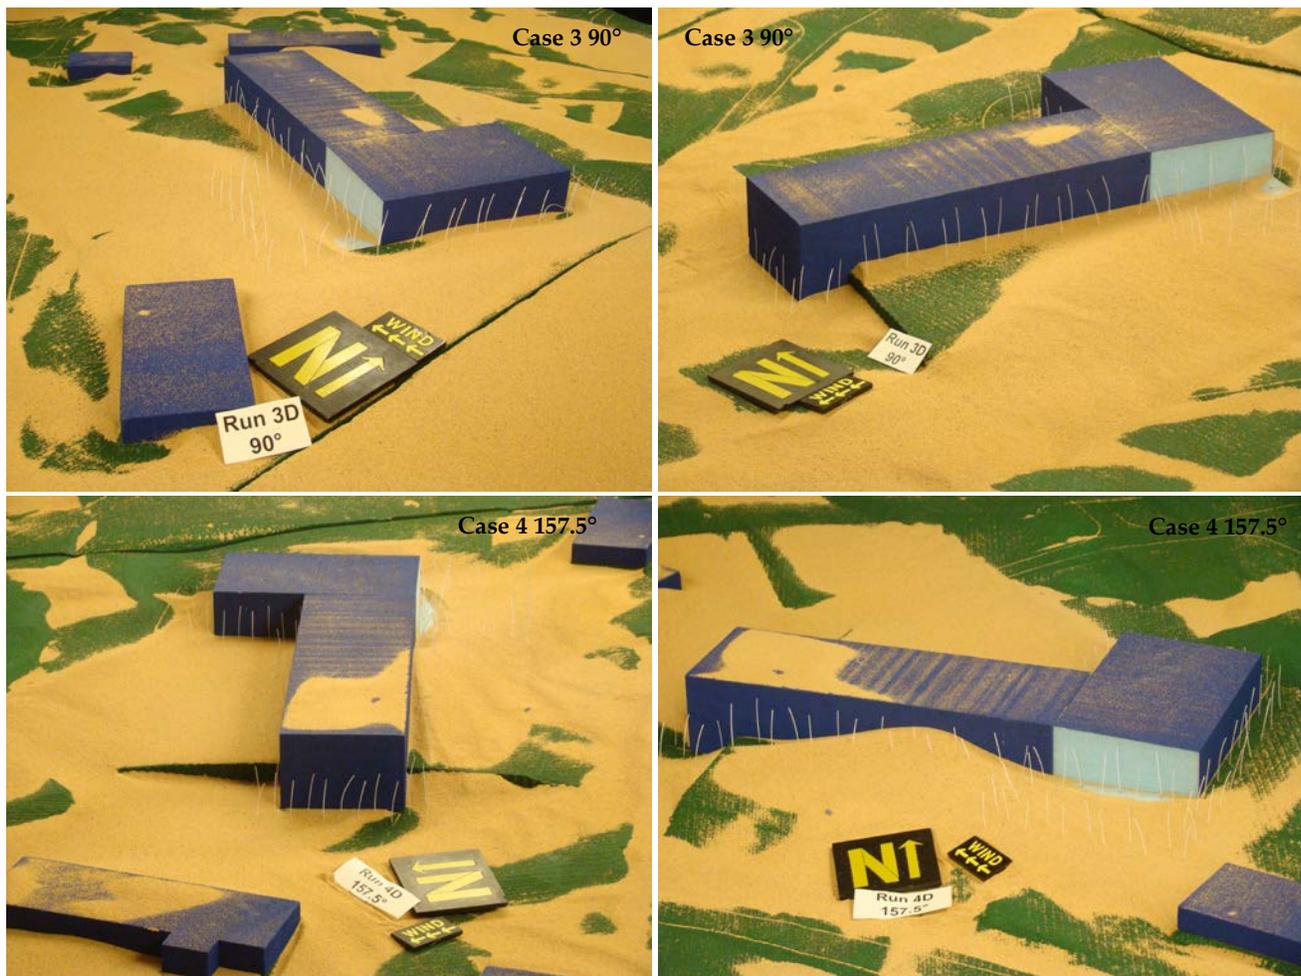
Figure 15 : Photographs of the snow accumulation and scouring around the VEOC (Model Configuration B).

Removing the south wing of the VEOC Building did not change the snow accumulation around the building significantly, see photographs in Figure 15 below. For both wind directions, the wind accelerates around the southeast building corner, scouring most of the snow material in that area.

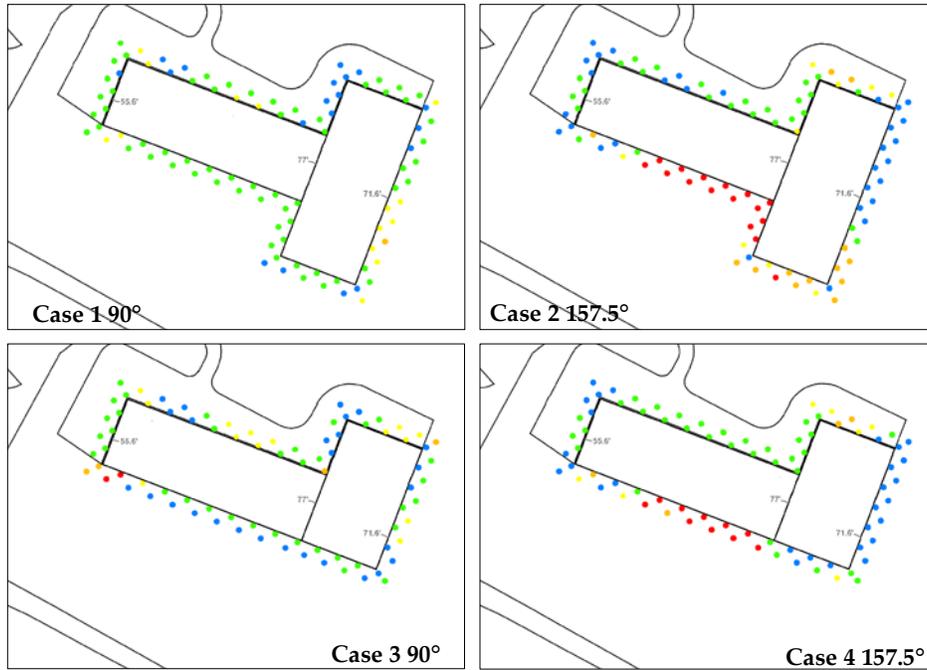
Figure 16 : Comparison of the snow accumulation and scouring around the VEOC for Model Configurations A and B.

Removing the south wing of the VEOC Building also caused a slight shift of the main snow deposition farther to the west along the southern building wall, as illustrated in Figure 16. The overall area around the VEOC with significant snow deposition was reduced slightly without the south wing, potentially reducing the amount of snow removal needed around the perimeter of the building.

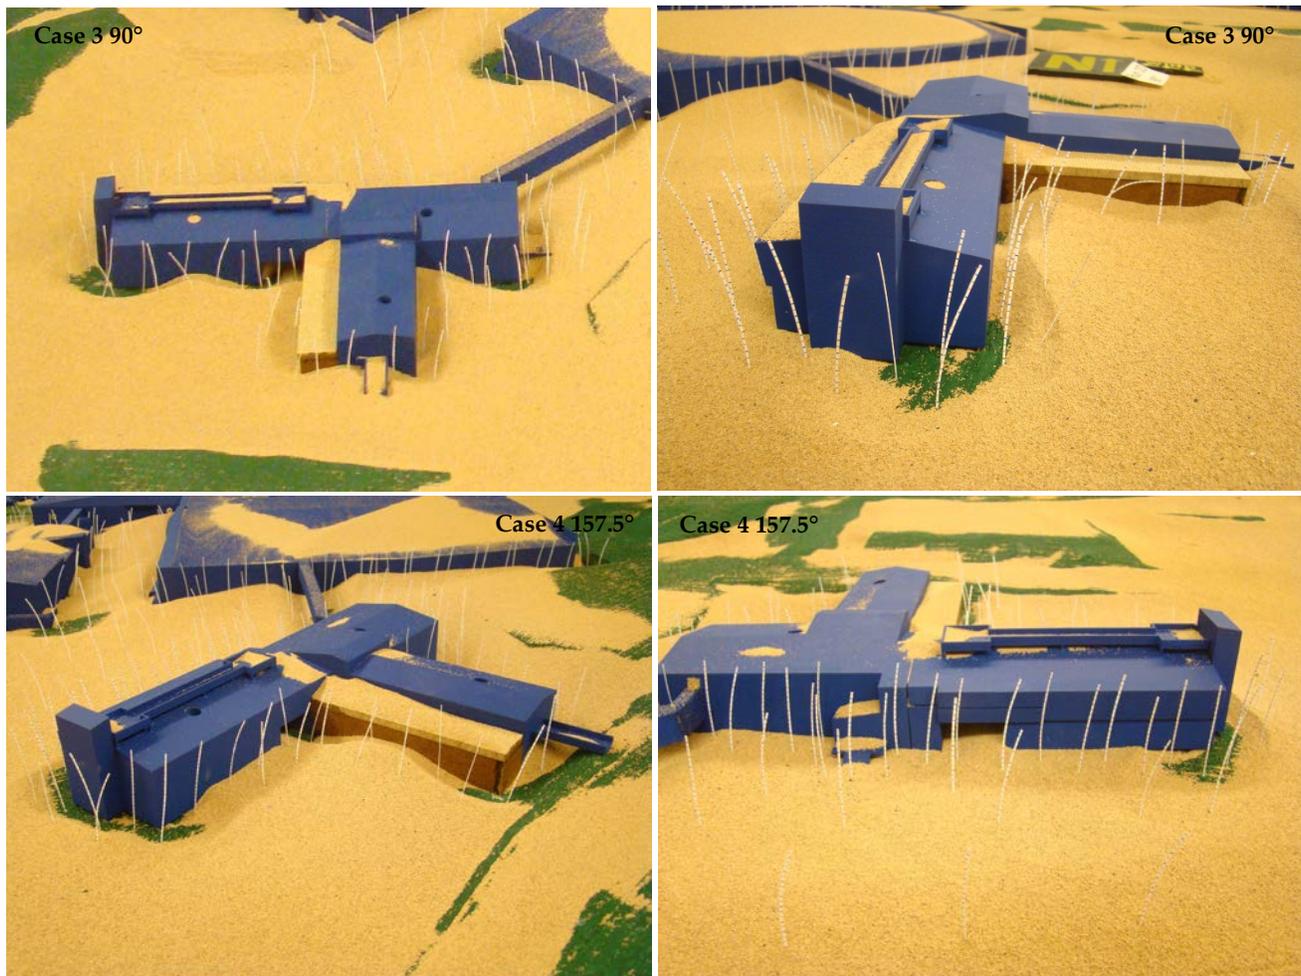
Figure 17 : Photographs of the snow accumulation and scouring around the IT Building (Model Configuration B).

For Building Configuration B, a cold storage facility was added to the IT Building. Photographs of the snow accumulation around the IT Building are shown in Figure 17 below. Overall, the snow accumulation around the building did not change significantly due to the building modifications.

The roof of the cold storage addition shows some snow accumulation due to the lower height than the surrounding roofs. As for the previous model configuration, significant snow accumulation can be seen in the pocket created by the existing east wing and the new south wing of the building. The breezeway stayed mostly clear of snow for both wind directions.

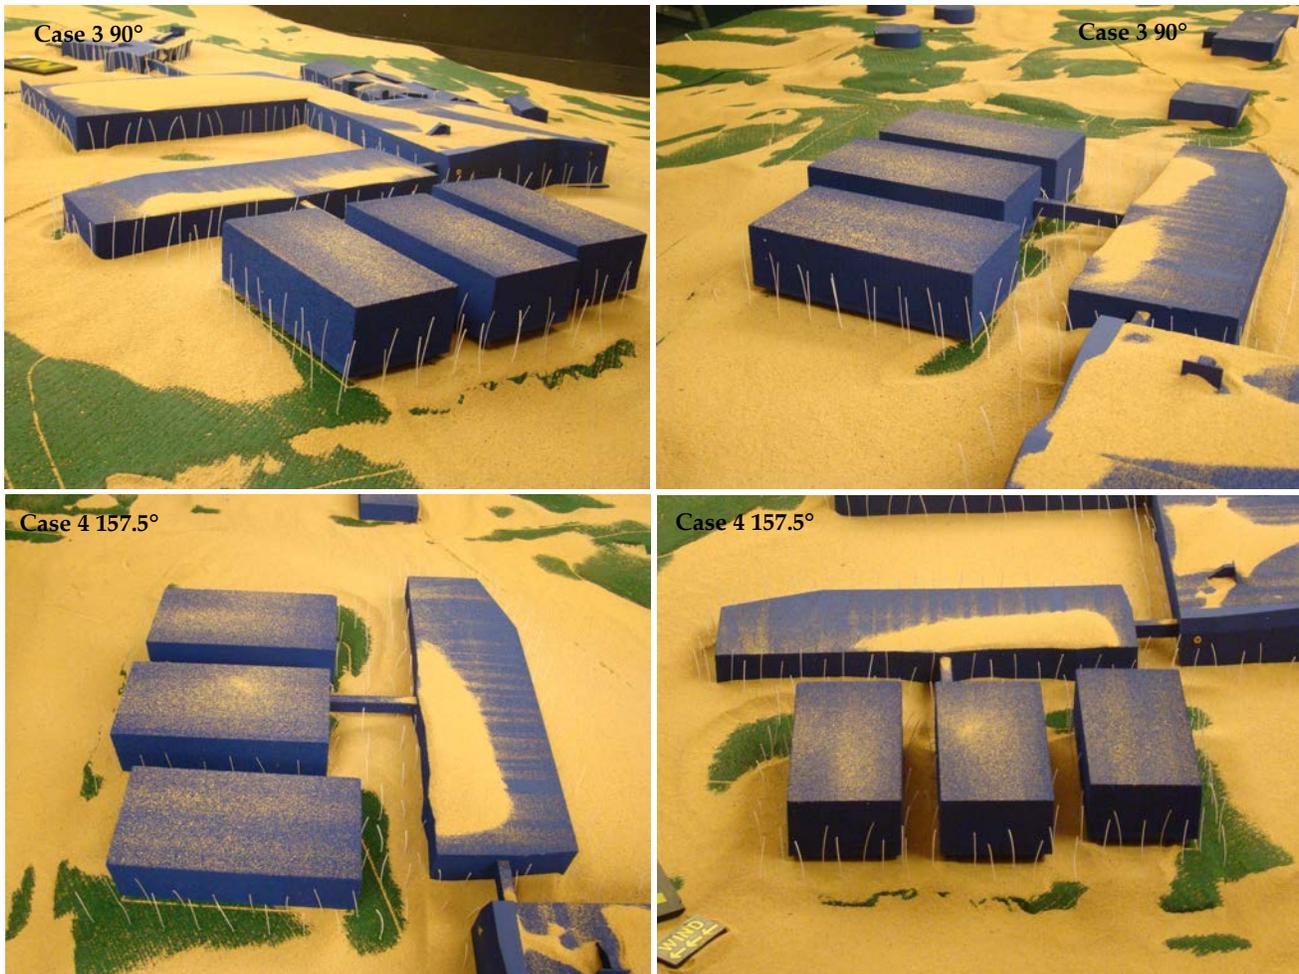
Figure 18 : Photographs of the snow accumulation and scouring around the Lodging Buildings (Model Configuration B).

The Lodging Buildings increased in height for this Building Configuration. Photographs of the snow accumulation around the Lodging Buildings are shown in Figure 18 below.

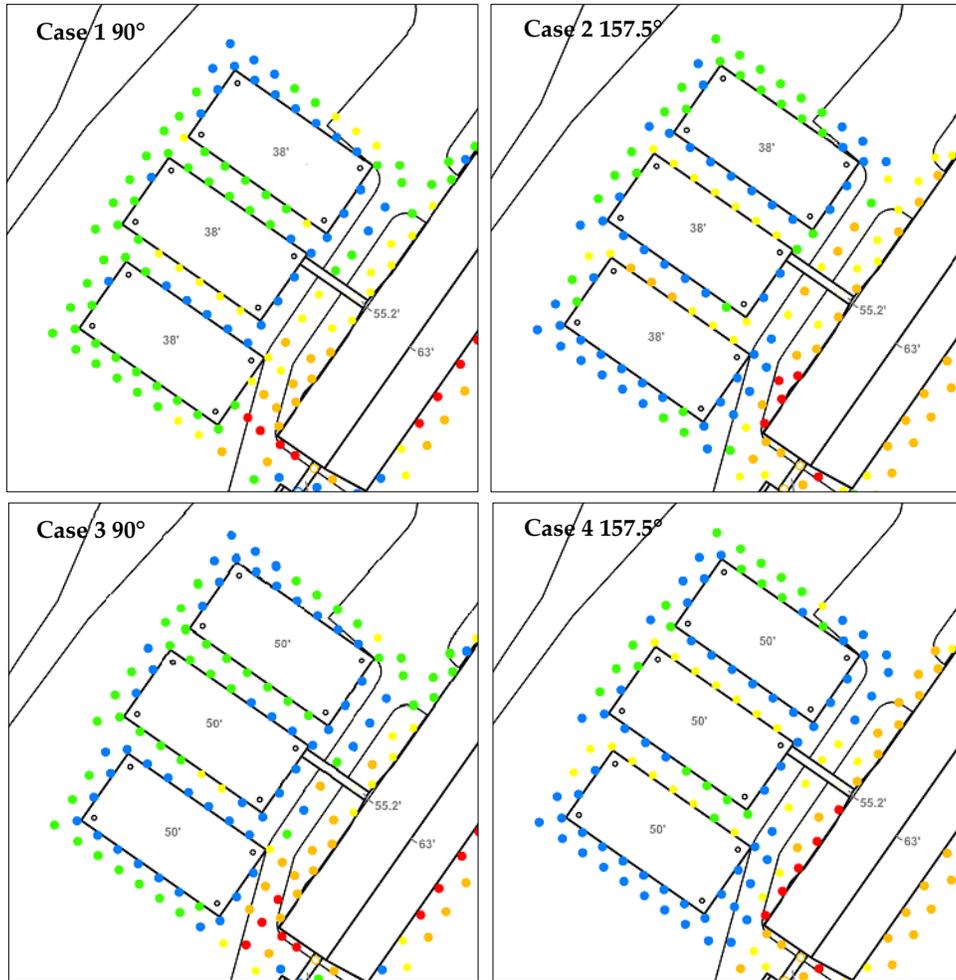
Figure 19 : Comparison of the snow accumulation and scouring around the Lodging Buildings for Model Configurations A and B.

Overall, snow deposition around the Lodging Buildings was minor for Building Configuration A and was reduced even more with the additional building height (see Figure 19). Again, significant scour around building corners can be seen due to accelerations of the wind in these areas.

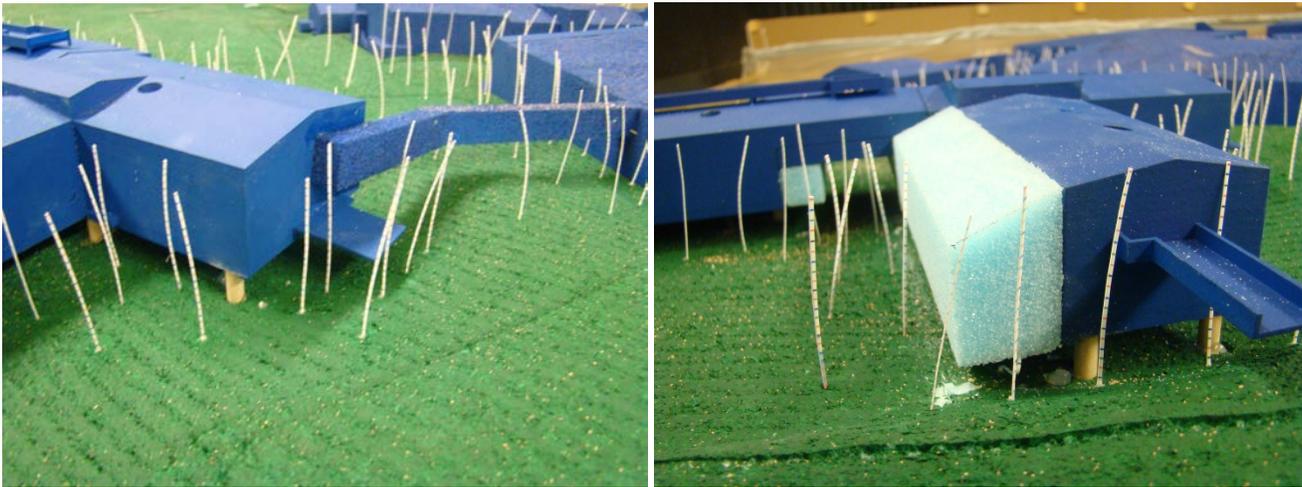
Figure 20: Photographs of the model setup in the wind tunnel for Model Configuration C.

In Cases 5 and 6, the taller Lodging Buildings remained and the VEOC Building layout stayed unchanged. An alternate bridge was installed connecting the Field Science Support and the IT Buildings. The roof of the added cold storage facility of the IT Building was sloped upward and the overall IT Building height above grade was increased. Photographs of the IT Building modifications are shown below (Figure 20).

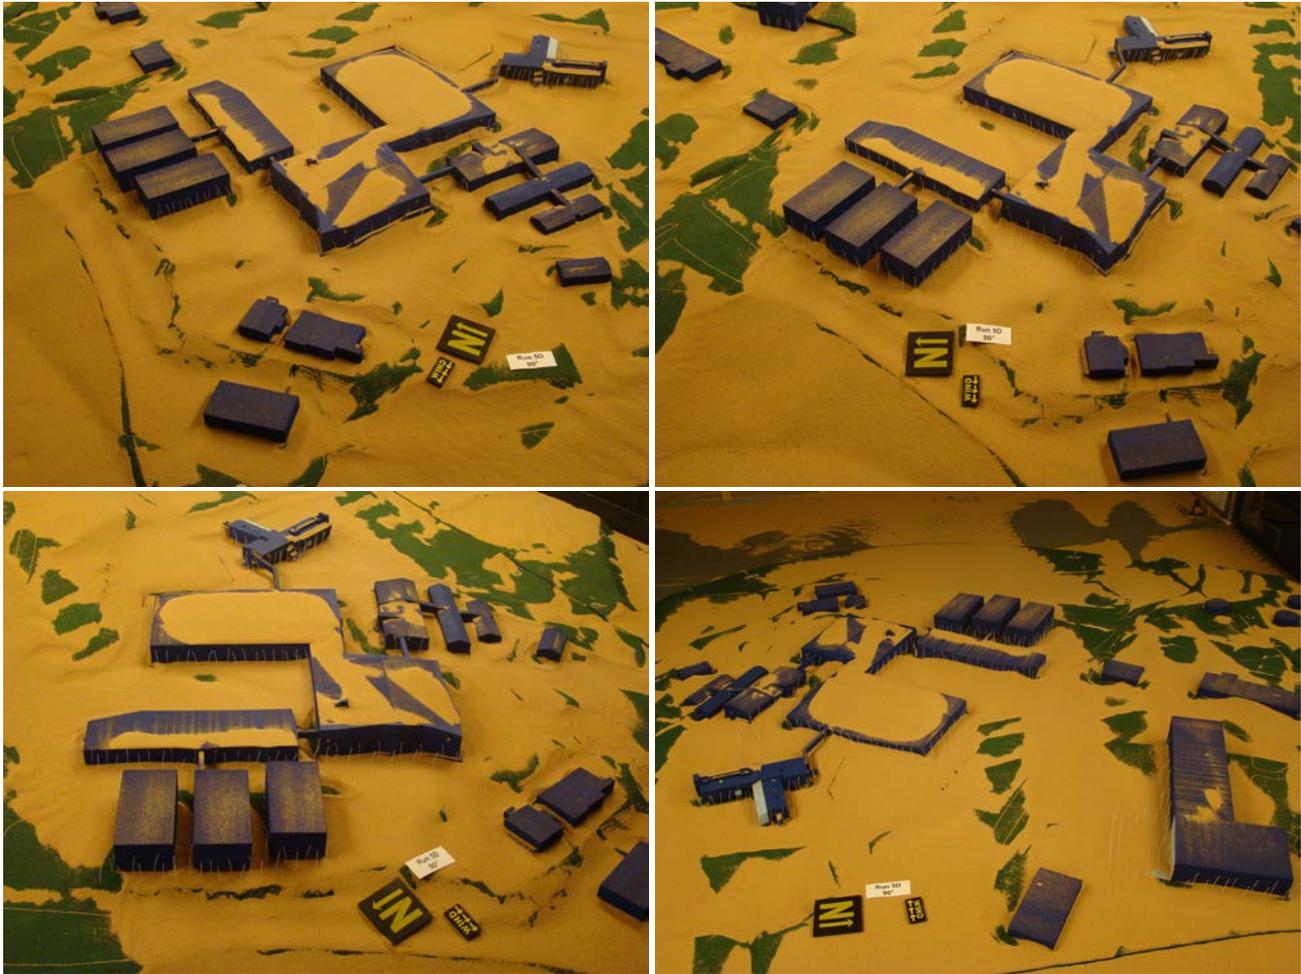
Figure 21a: Photographs of the snow accumulation and scouring: Case 5: Model Configuration C with a wind direction of 90°.

Photographs of the resulting snow accumulation and scouring patterns for Cases 5 and 6 are shown in Figure 21. Drawings with the color-coded snow depths for all test cases are shown in Appendix A.

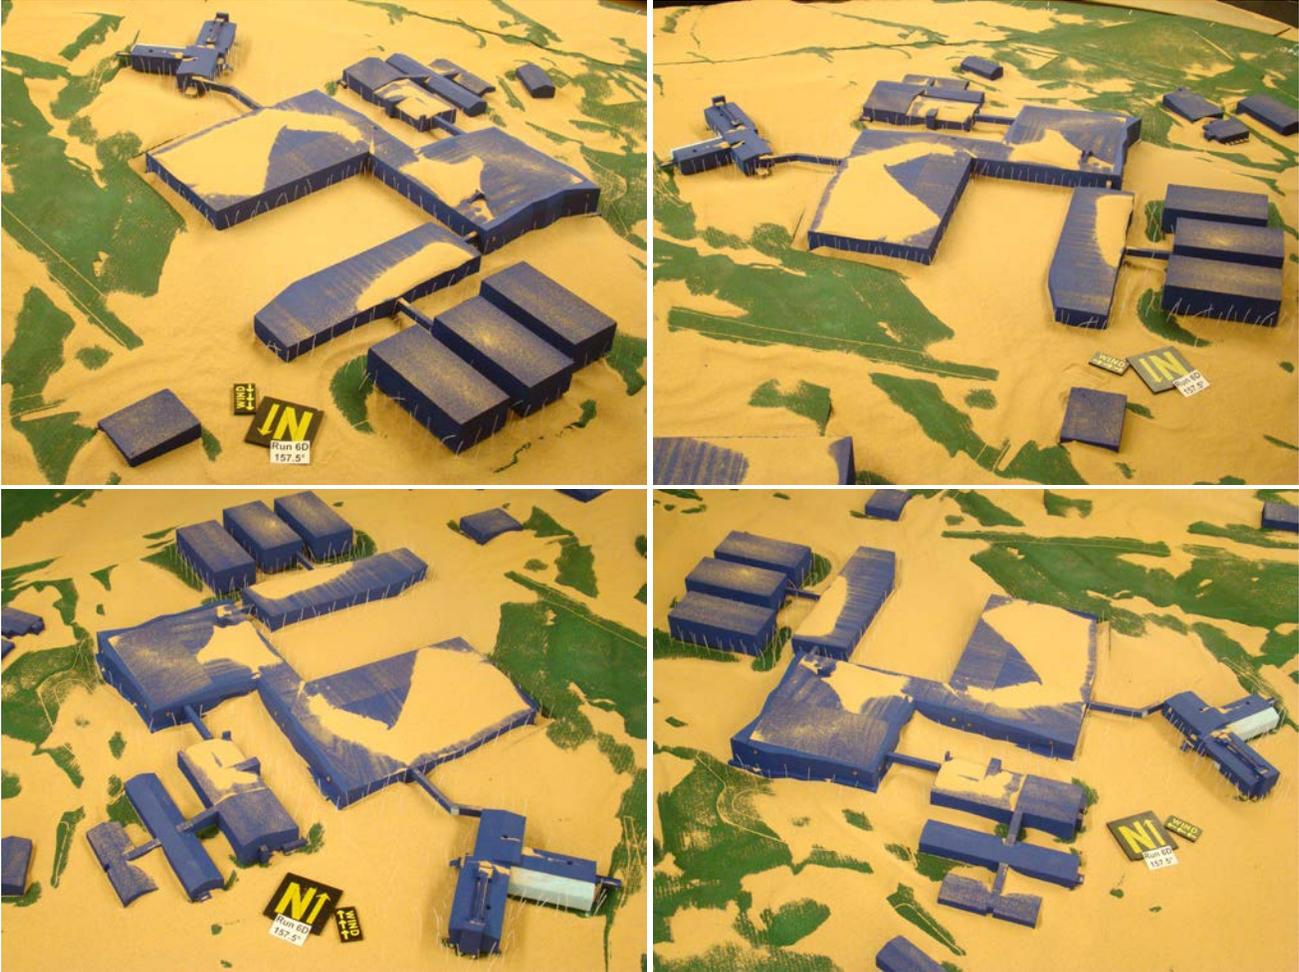
Figure 21b: Photographs of the snow accumulation and scouring: Case 6: Model Configuration C with a wind direction of 157.5°.

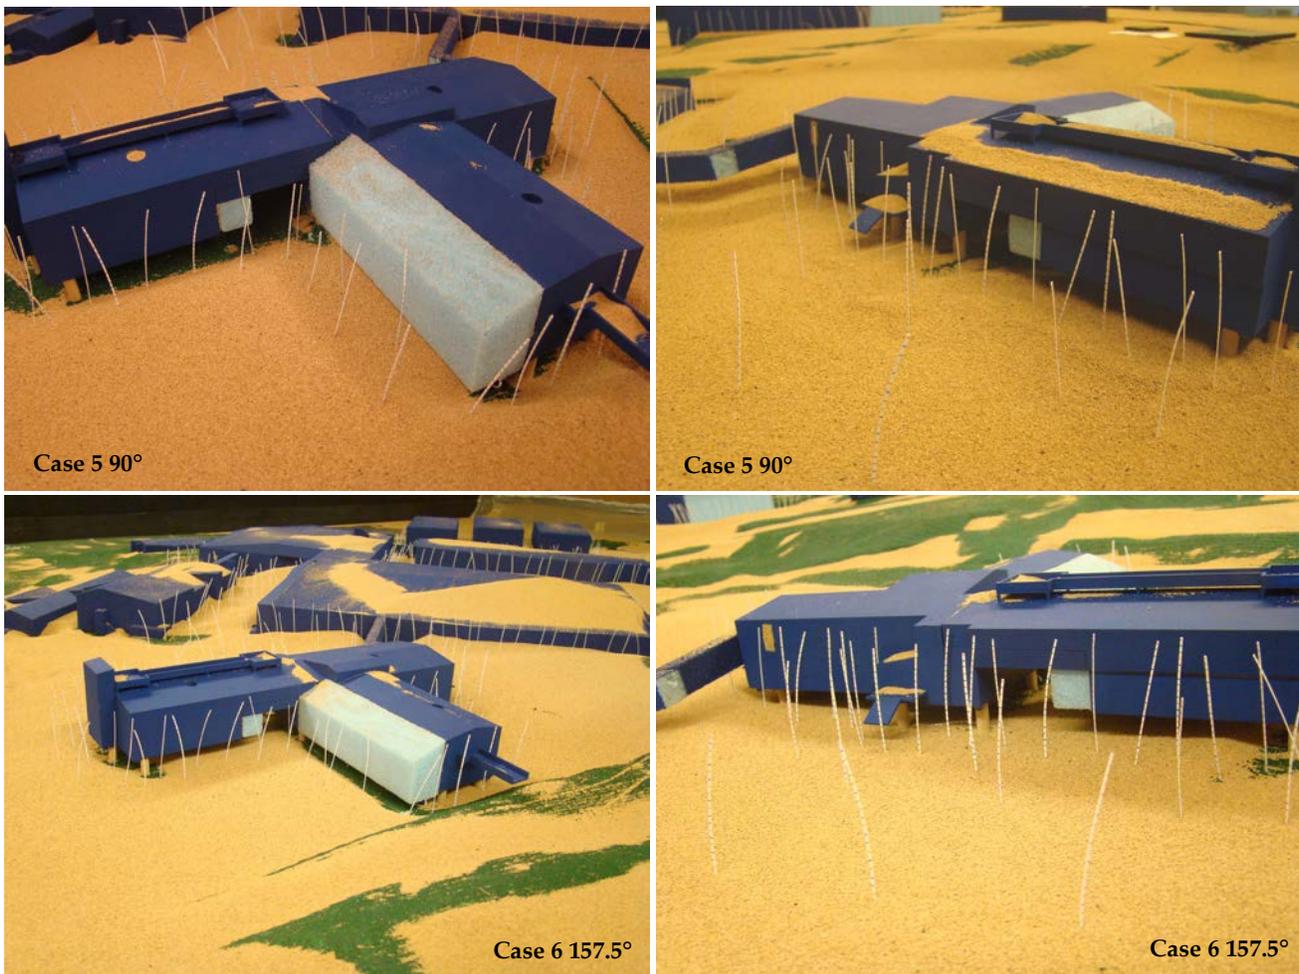
Figure 22 : Photographs of the snow accumulation and scouring around the IT Building (Model Configuration C).

For Building Configuration C, the roof of the added cold storage facility was sloped upward to connect with the east wing roof. The overall IT Building height above grade was increased, raising the entire building up on stilts. In addition, an alternate bridge was installed connecting the Field Science Support and the IT Buildings.

Photographs of the snow accumulation around the IT Building are shown in Figure 22 below. Overall, the snow accumulation around the building decreased significantly (see Figure 23). The gap underneath the building allows air flow and snow scouring; significantly reducing the snow accumulation around the building. The breezeway stayed clear of snow as well.

The sloped cold storage roof eliminates the snow accumulation due to roof height differences in Building Configuration B. The change of the bridge connecting the IT Building to Field Science Support had no impact on the surrounding snow accumulation patterns.

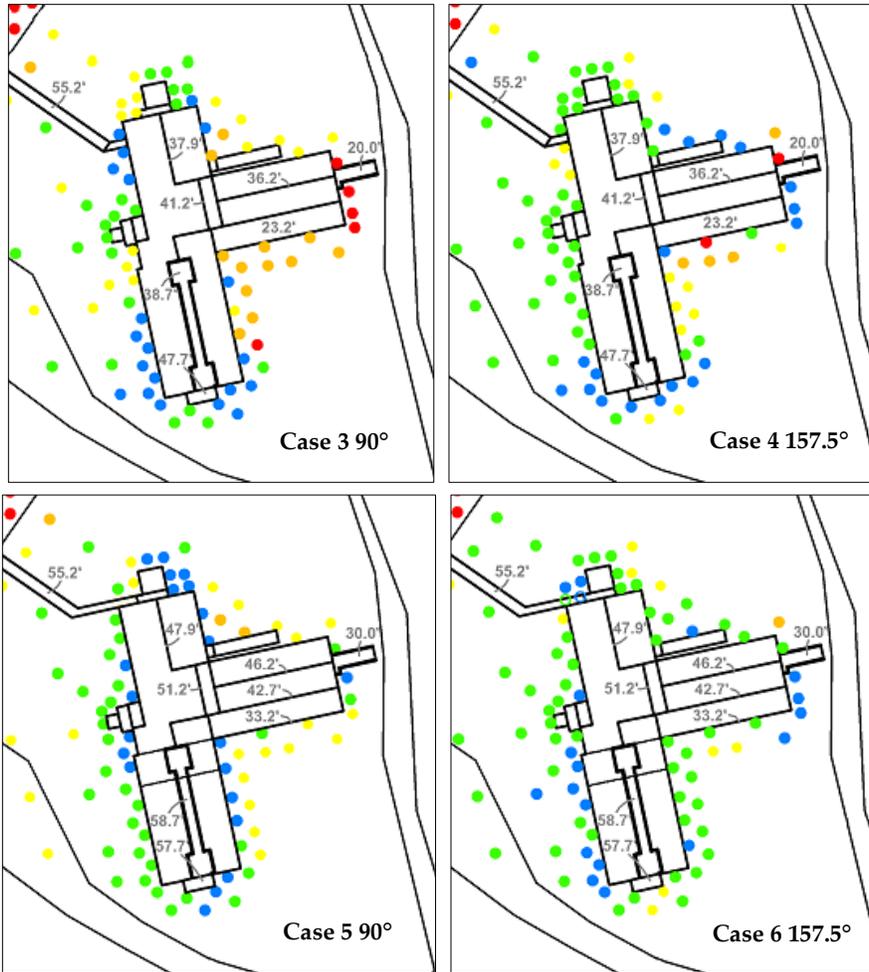
Figure 23 : Comparison of the snow accumulation and scouring around the IT Building for Model Configurations B and C.

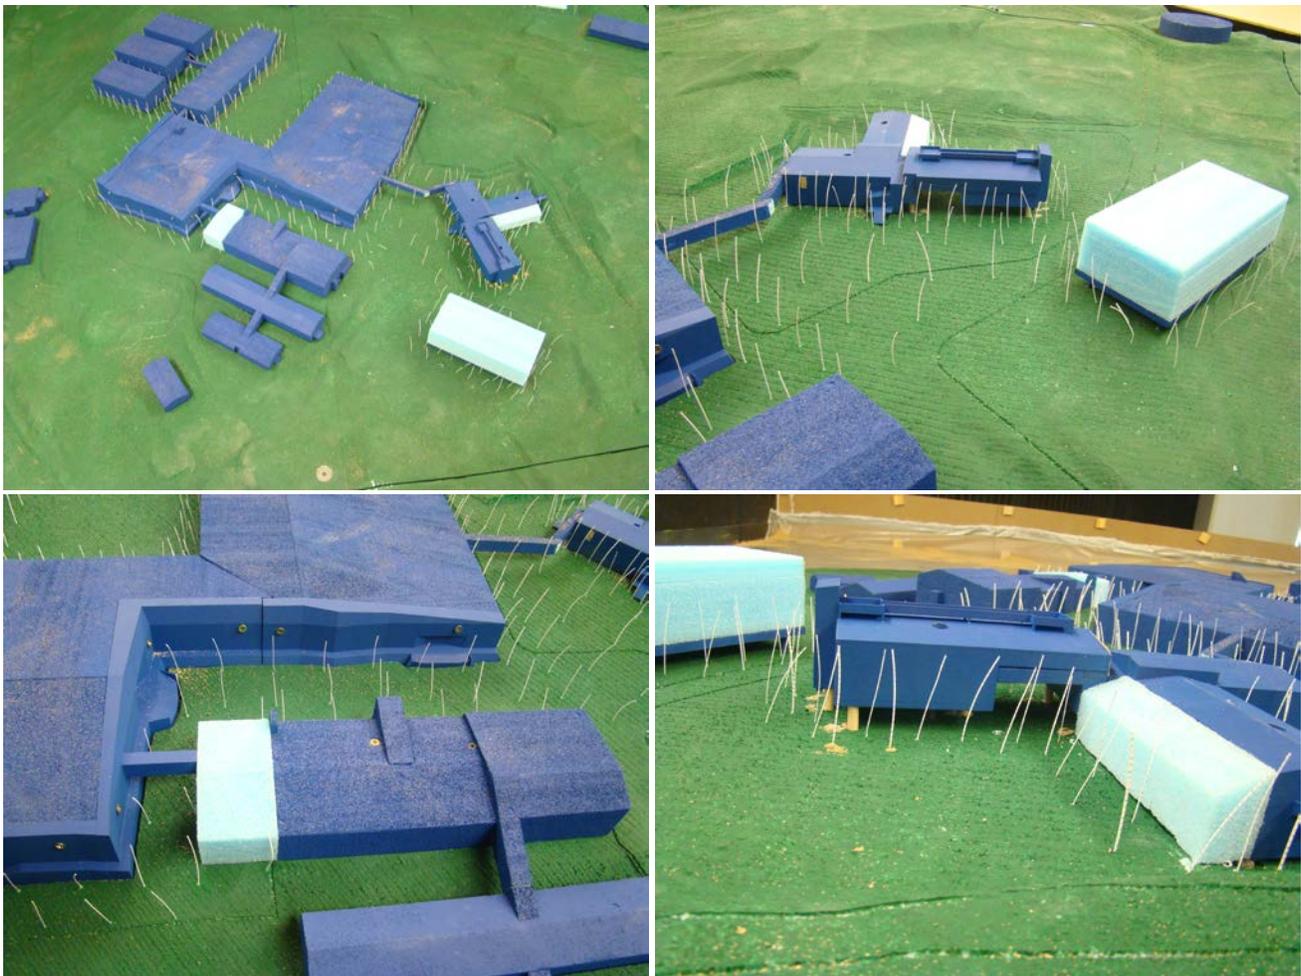
Figure 24: Photographs of the model setup in the wind tunnel for Model Configuration D.

In model Configuration D, no changes were made to the VEOC Building. The taller Lodging Buildings west of the Central Services Buildings remained; however, an additional Lodging Building of the same height was placed south of the IT Building. The alternate bridge configuration of the IT Building remained, as did the addition of the sloped roof to cold storage. The height of the IT Building above grade changed, however. The existing IT Building portions (north and east wings) stayed close to grade and the new building portion (south wing) was raised ~10ft above grade on stilts. Furthermore, the width of the IT Building breezeway was increased. The Crary Lab Building was extended to the west, in an effort to reduce the width of the gap between Crary and Central Services, to more closely match the previous wind tunnel assessment.

Photographs of the added and modified Buildings are shown below (Figure 24).

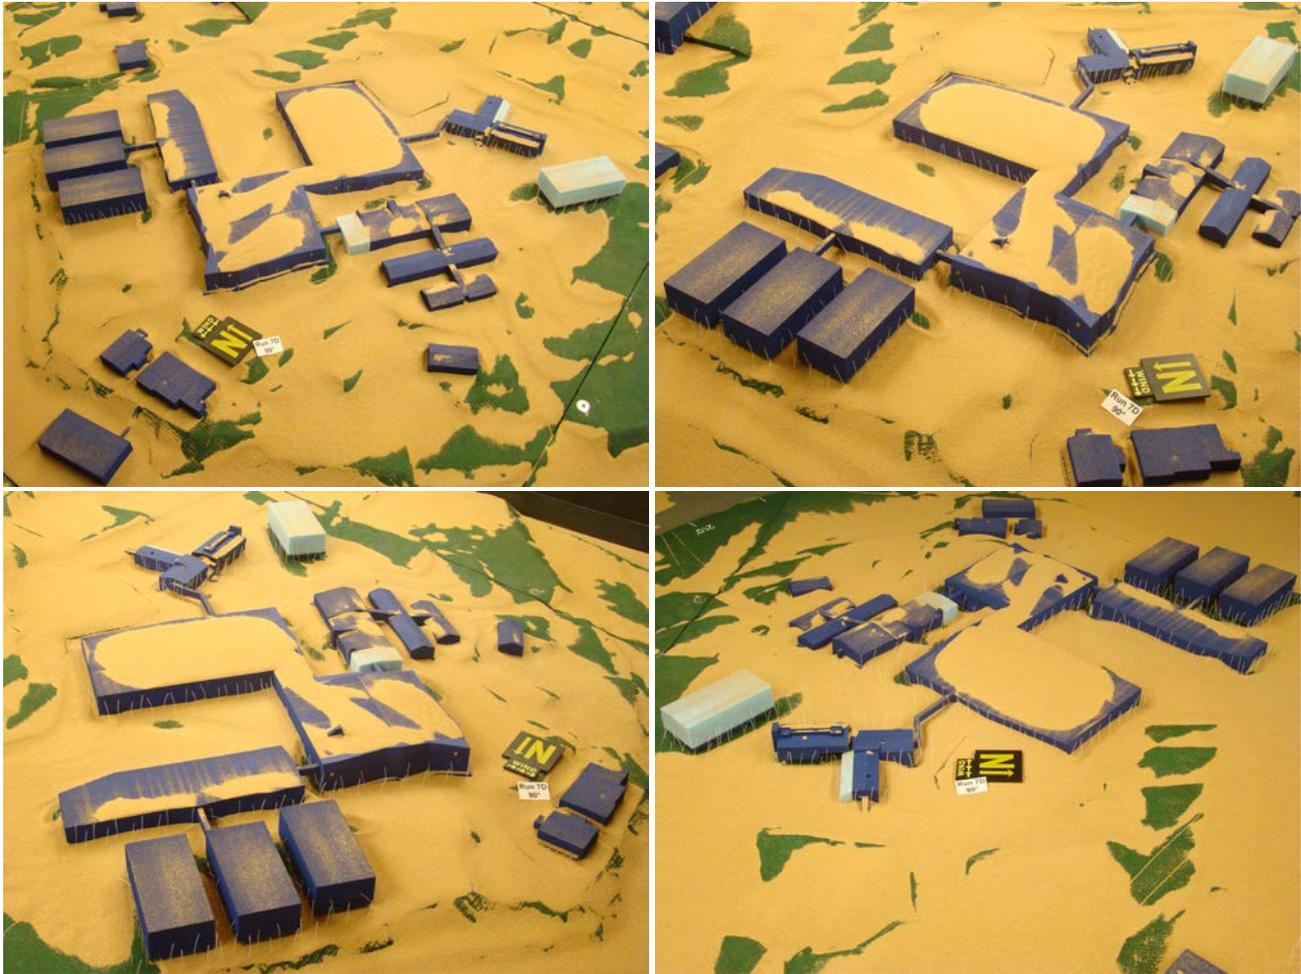
Figure 25a: Photographs of the snow accumulation and scouring: Case 7: Model Configuration D with a wind direction of 90°.

Photographs of the resulting snow accumulation and scouring patterns for Cases 7 and 8 are shown in Figure 25. Drawings with the color-coded snow depths for all test cases are shown in Appendix A.

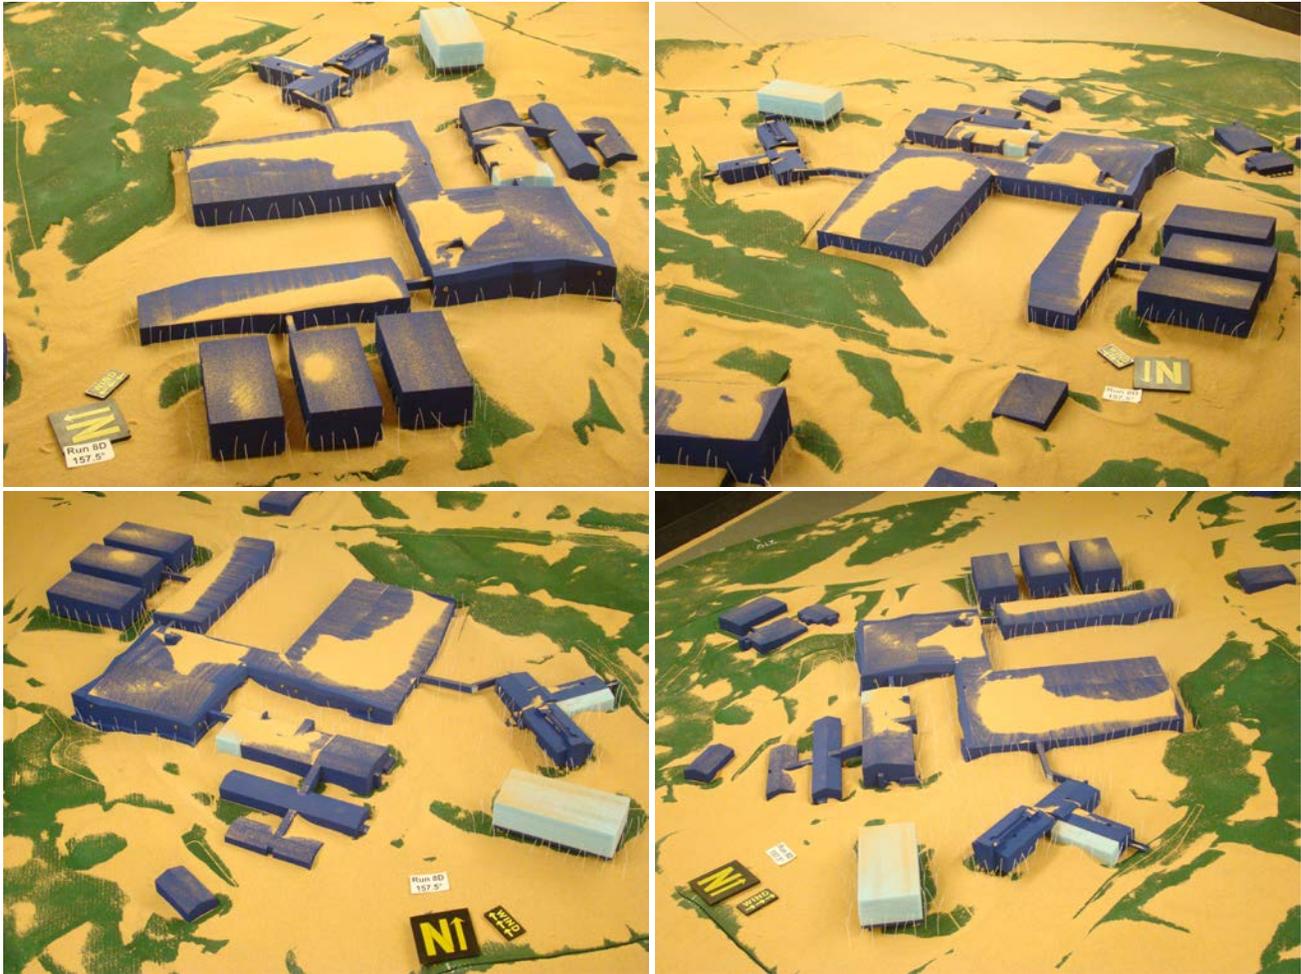
Figure 25b: Photographs of the snow accumulation and scouring: Case 8: Model Configuration D with a wind direction of 157.5°.
