FINAL REPORT
CPP PROJECT 9494

MCMURDO STATION SNOW MODELING

McMurdo Station, Antarctica

NOVEMBER 2016

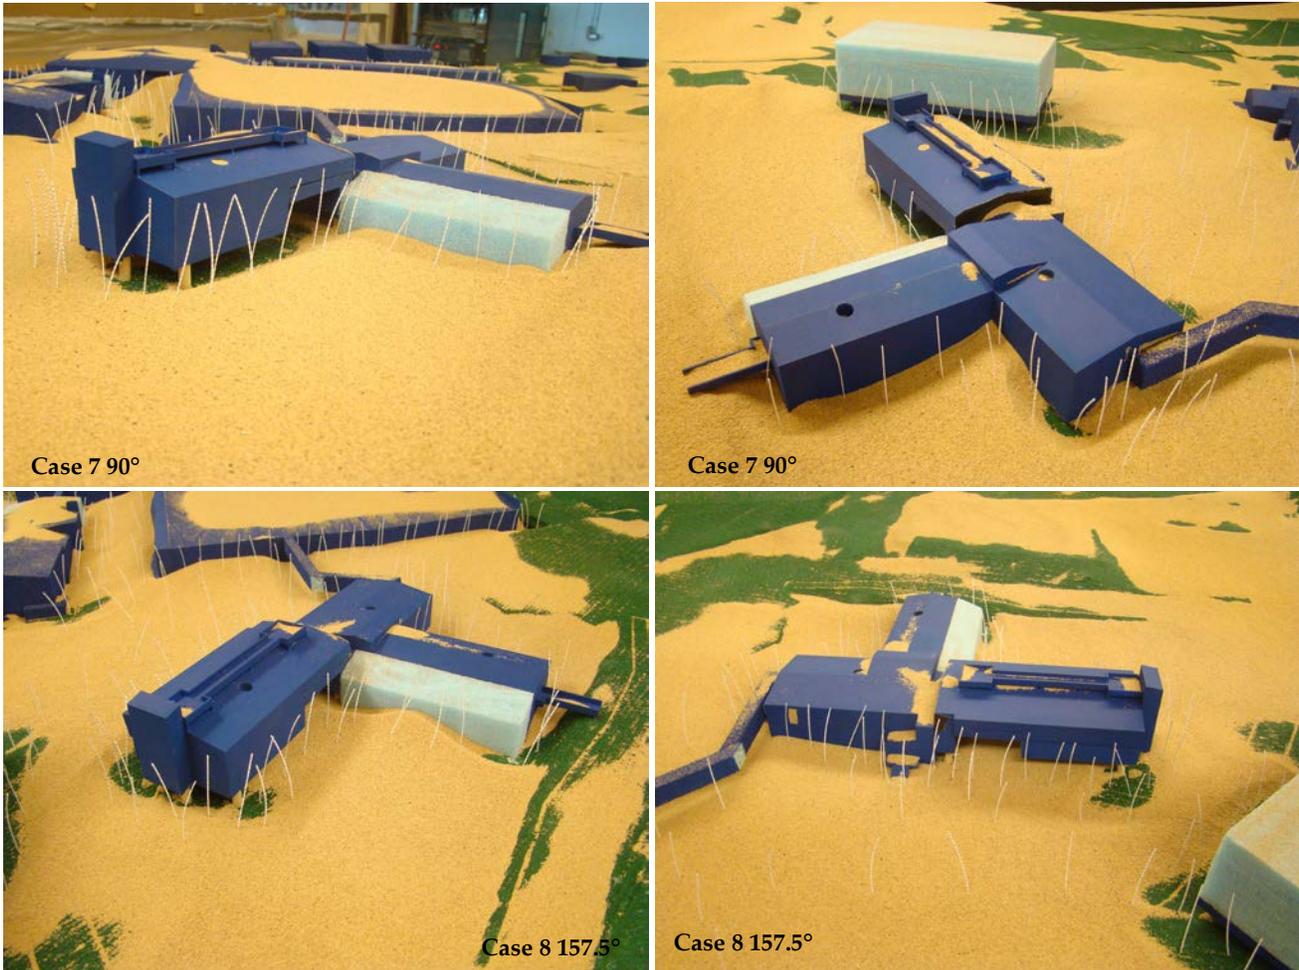
Figure 26 : Photographs of the snow accumulation and scouring around the IT Building (Model Configuration D).

For Building Configuration D, the alternate bridge configuration and the addition of the sloped roof to the cold storage remained. The base of existing IT Building portions (north and east wings) stayed at grade and the new building portion (south wing) was raised up on stilts. The width of the breezeway was increased.

Photographs of the snow accumulation around the IT Building are shown in Figure 26 below. Overall, the snow accumulation around the south side of the building decreased (see Figure 27). The gap underneath the south building portion allows air flow and snow scouring; reducing the snow accumulation in the area. The sloped cold storage roof eliminates the snow accumulation due to roof height differences in Building Configuration B. Again, the alternate bridge configuration did not change the nearby snow accumulation patterns and the breezeway stayed mostly clear of snow for both wind directions. Increasing the width of the breezeway does not seem to have a significant effect.

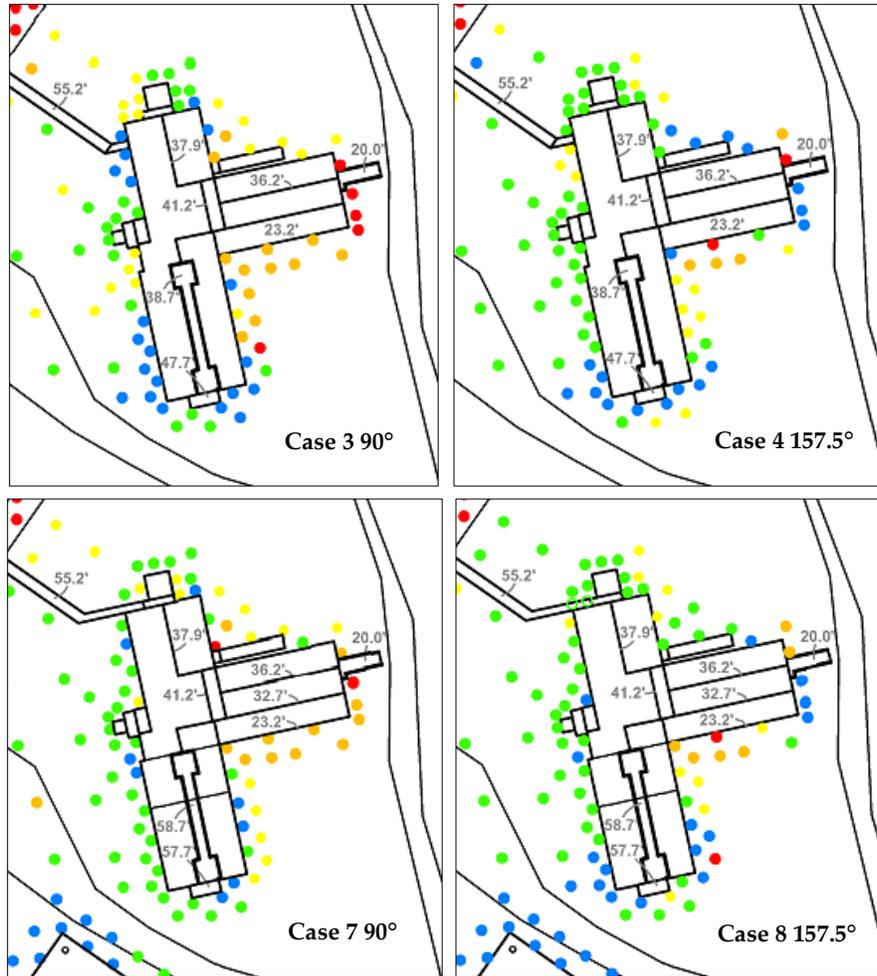
Figure 27 : Comparison of the snow accumulation and scouring around the IT Building for Model Configurations B and D.

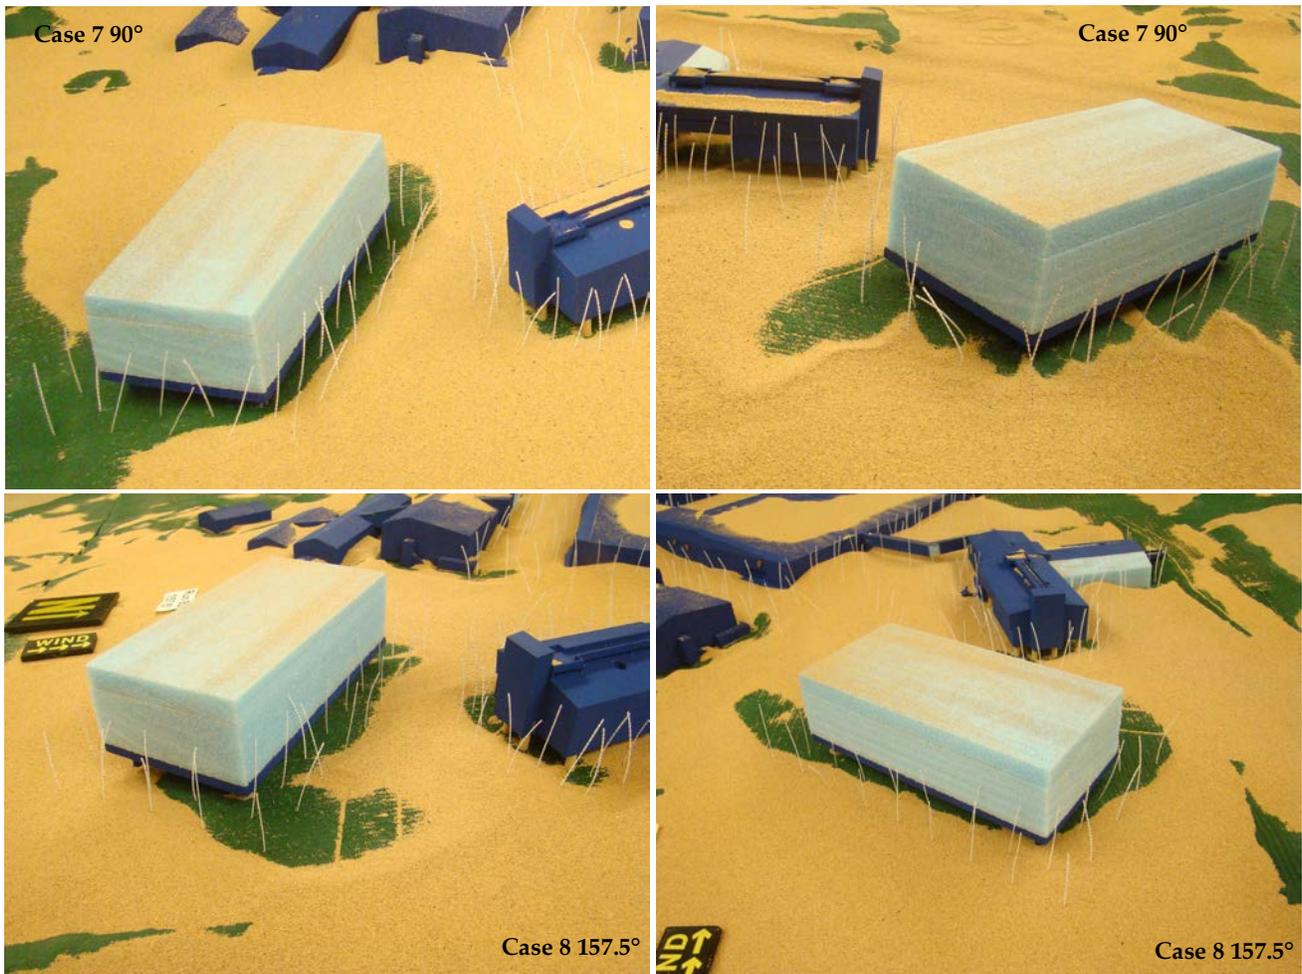
Figure 28 : Photographs of the snow accumulation and scouring around the additional Lodging Building (Model Configuration D).

An additional Lodging Building was placed south of the IT Building. Photographs of the snow accumulation around the additional Lodging Building are shown in Figure 28 below.

Significant scour around building corners as well as underneath the building can be seen due to accelerations of the wind in these areas. Overall, snow accumulation around the additional Lodging Building is insignificant.

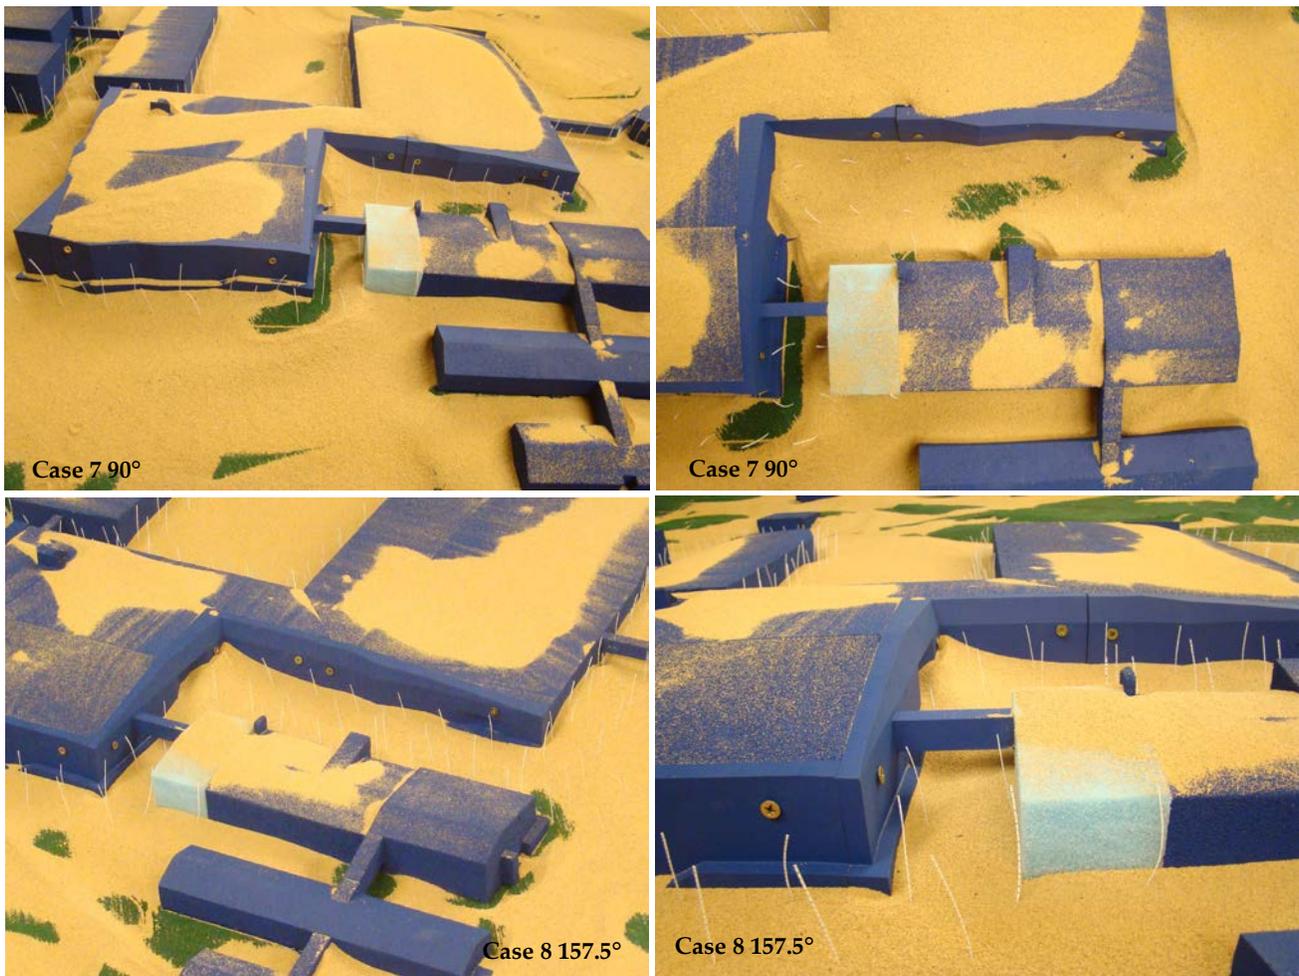
Figure 29 : Photographs of the snow accumulation and scouring in the Central Services Building Entrance area (Model Configuration D).

For Building Configuration D, the Crary Lab Building was extended to the west, in an effort to reduce the width of the gap between Crary and Central Services, in an effort to increase flow accelerations in the area. Photographs of the snow accumulation in the Central Services Building Entrance area are shown in Figure 29 below.

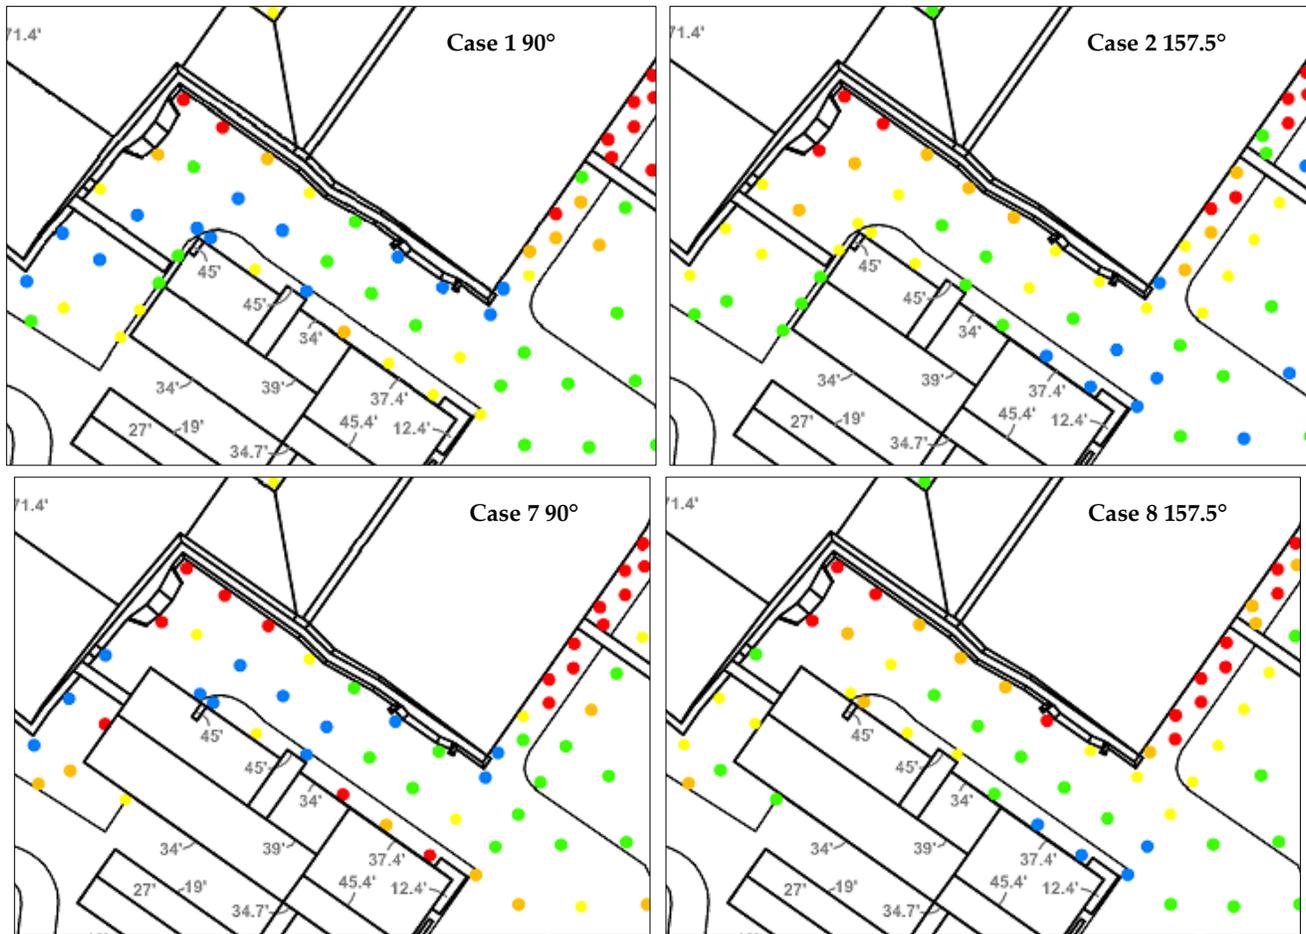
Figure 30 : Comparison of the snow accumulation and scouring in the Central Services Building Entrance area for Model Configurations A and D.

Overall, the snow accumulation in the main entrance area is very similar for both Building Configurations A and D (see Figure 30). Reducing the gap between Crary and Central Services did indeed increase flow accelerations in the area, however, the overall deposition of snow in the building corner north of the entrance stayed the same.

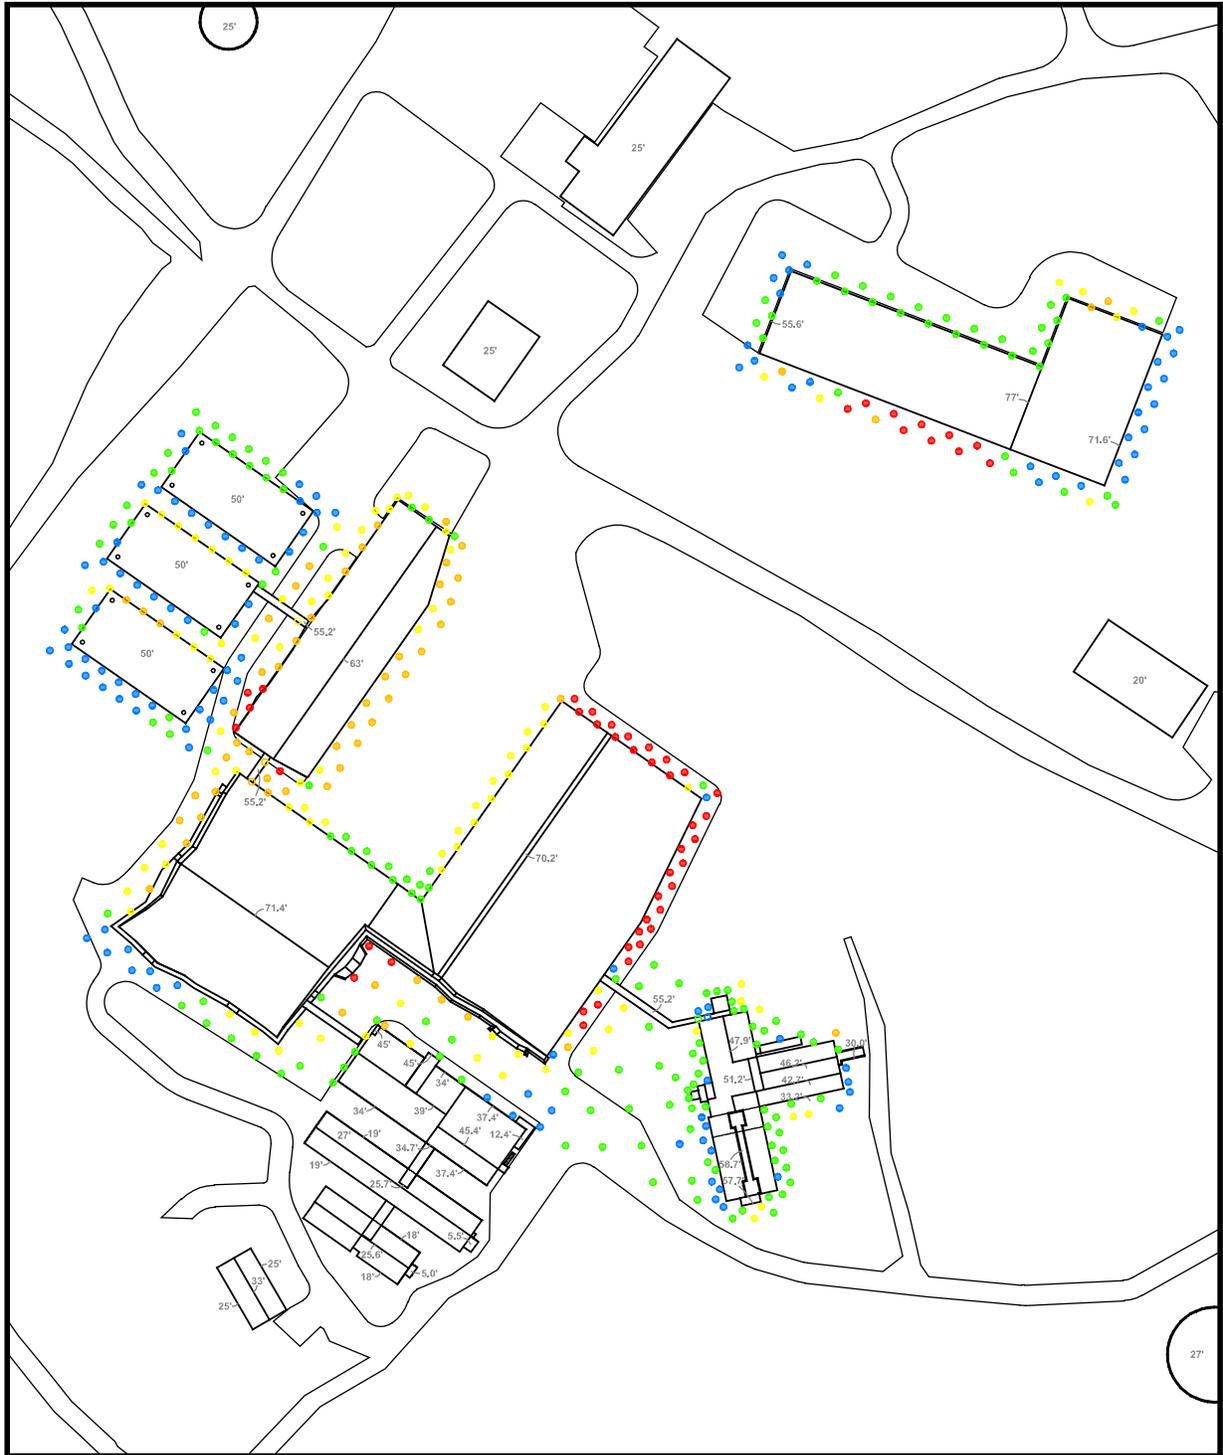
RUN 6D-157.5°

SNOW DEPTH
● - Lightest
● - Medium
● - Deepest

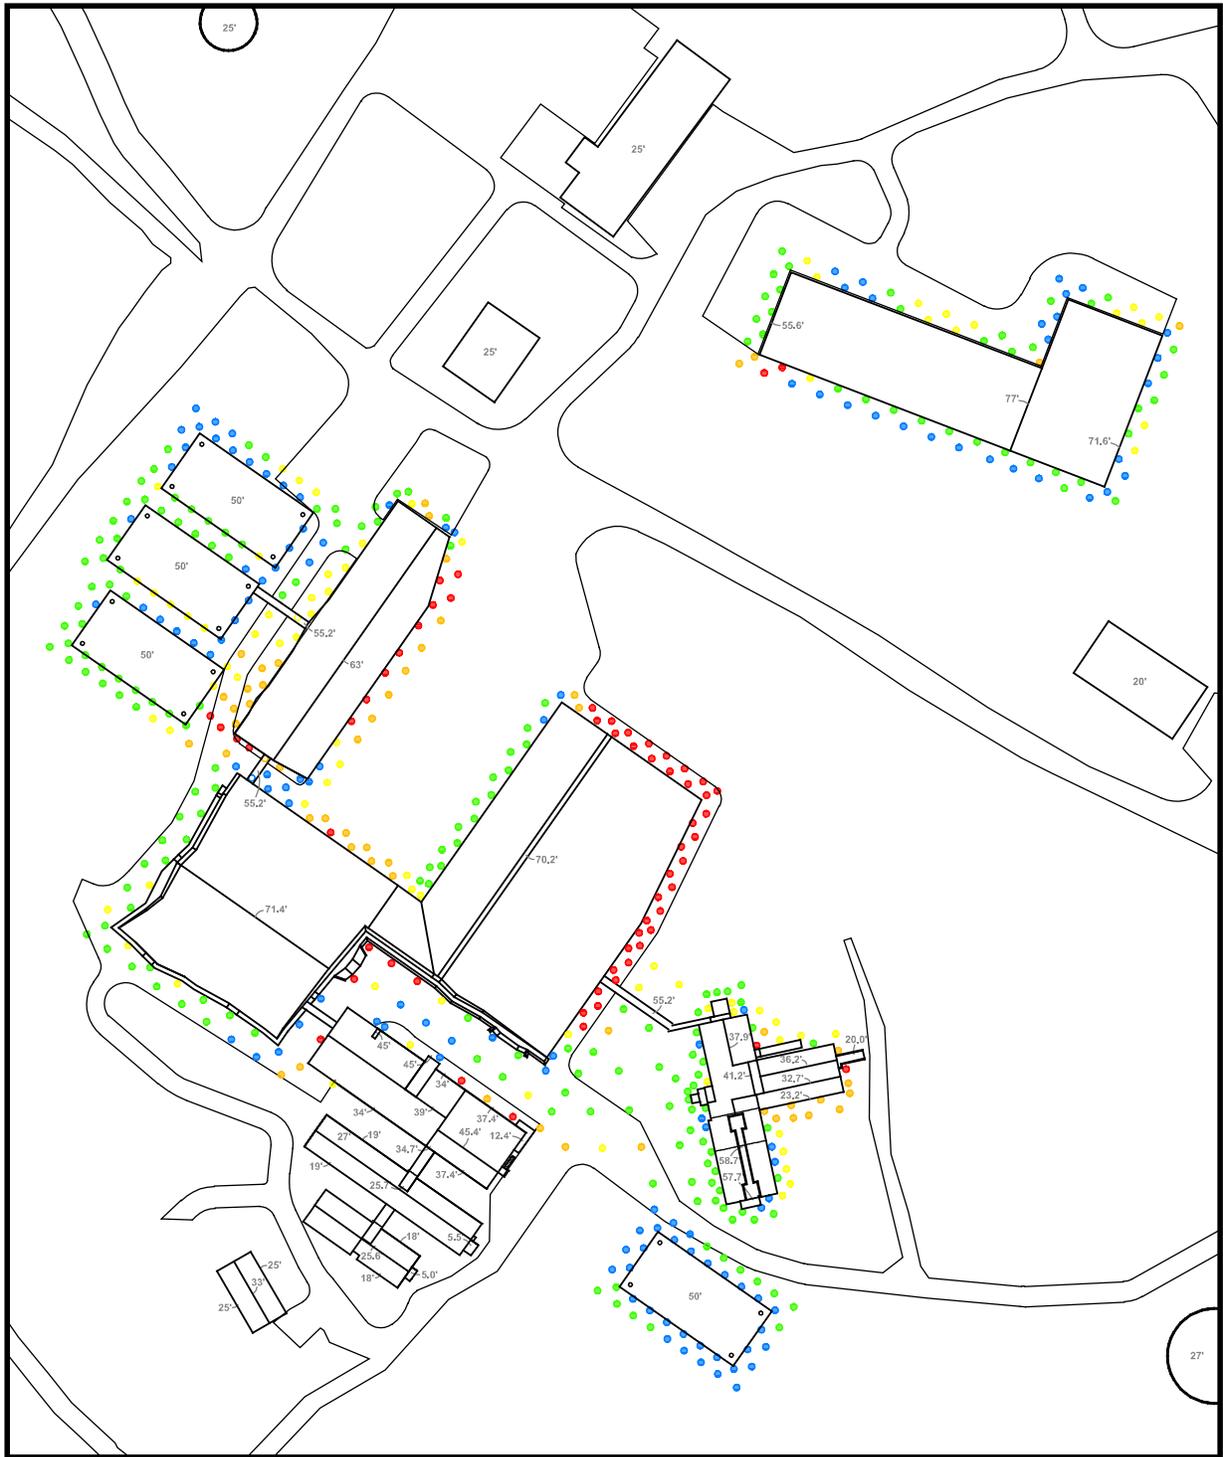
RUN 7D-90°

SNOW DEPTH
● - Lightest
● - Medium
● - Deepest

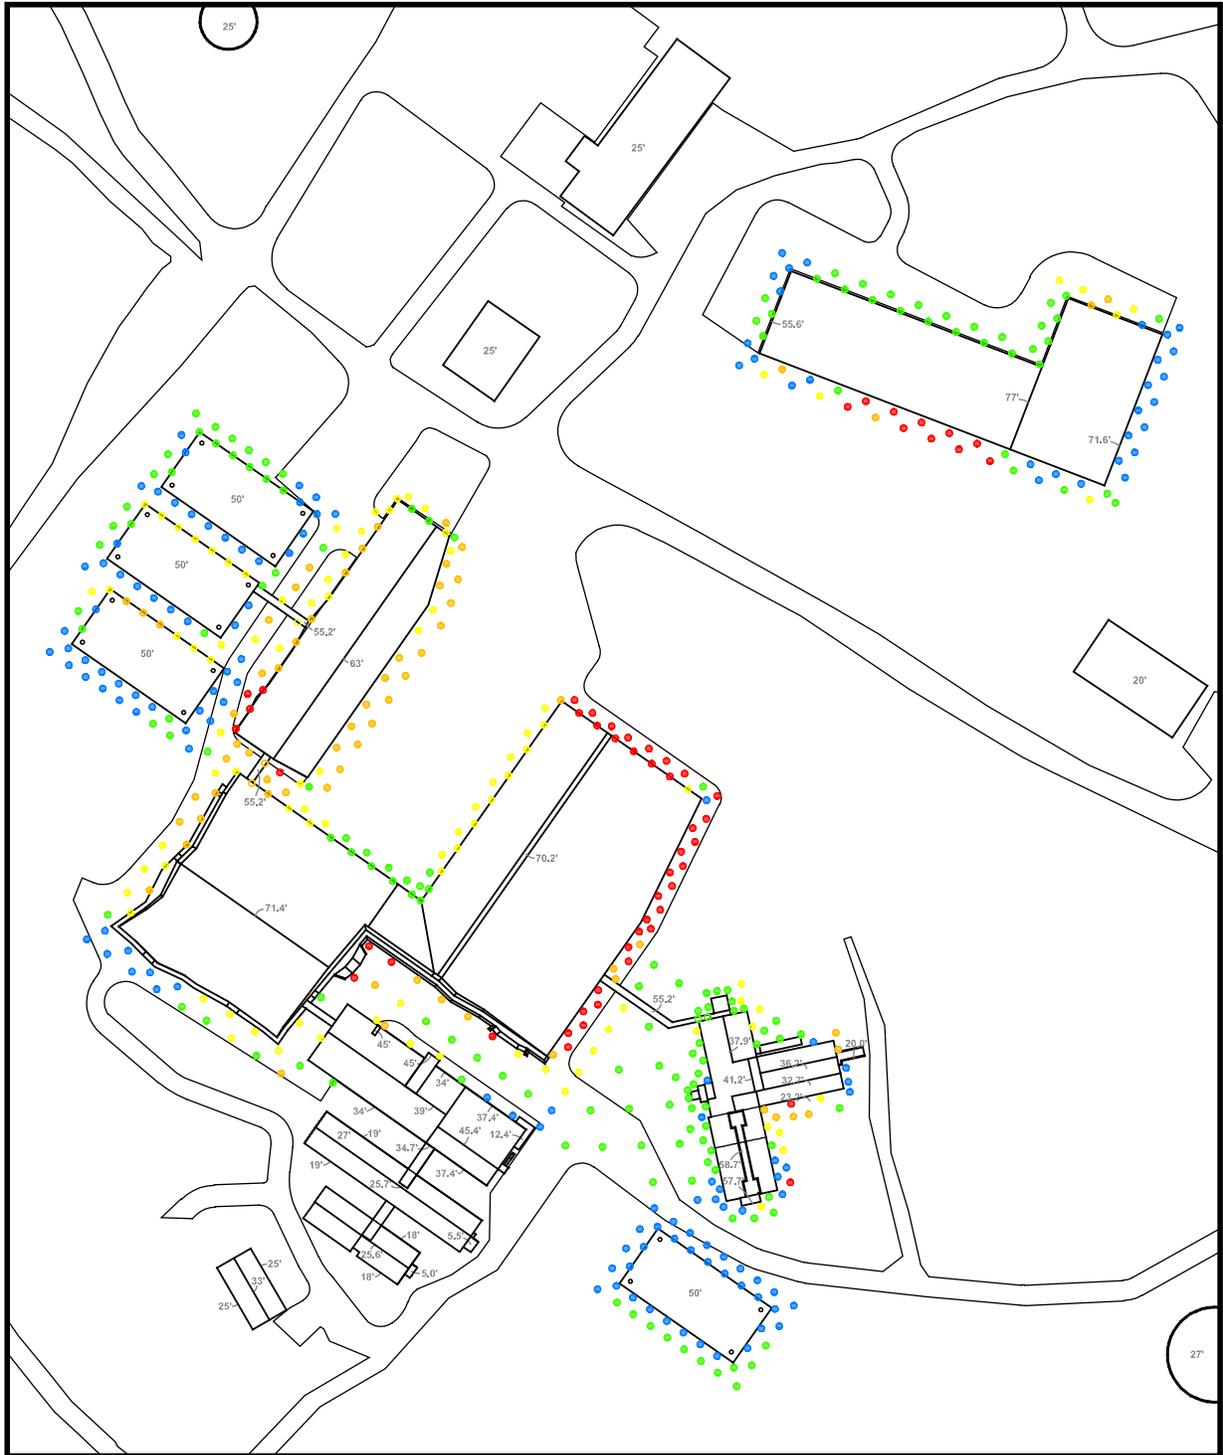
RUN 8D-157.5°

SNOW DEPTH
● - Lightest
● - Intermediate
● - Deepest
